FIELD TRIP TO SHOBARA HILLS AND ENVIRONS

Organized by : Japan Landslide Society (Kansai Branch)

Date : 28th September, 2011

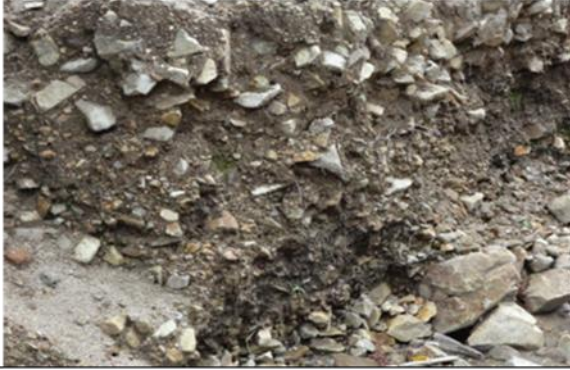
- The energy of the mud and debris flow was adjudged to be of high magnitude. The result was observable in the field as big boulders, rocks and uprooted trees were deposited at the toes of the landslides.

fig 1: Characteristic material composition at toe of landslide #5

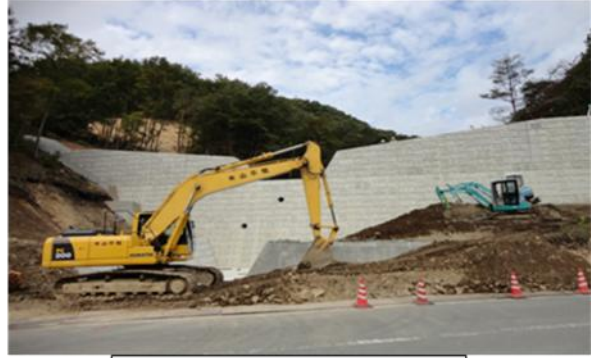
fig 2: Remediation work at Site #4

This was seen at Site #4. The landslide occurred in July, 2010 after an intense rainfall causing heavy debris flows which crossed the highway (route 445) and attacked a house situated just opposite the landslide and in front of a drainage channel. One fatality was recorded with total destruction of the property (Igwe and Fukuoka, 2010).

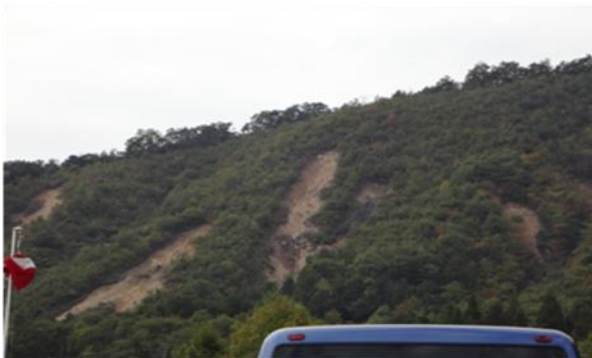
- Generally, a close observation from a distance of about 50m on Shobara Hills show a characteristic side-by-side feature of the Hills. The landslide surfaces (failure plane), were seen to be reddish to brownish coloured while the stable vegetation cover lies adjacent to the landslide surface. This characteristic feature is similar to an unripe (green) orange that is peeled in a like fashion where its skin is removed in spaces of 3cm. Prof. F. Wang termed the phenomenon '**Skin Failure.**'

fig 3: Characteristic differential "peeling" of some parts of Shobara Hills

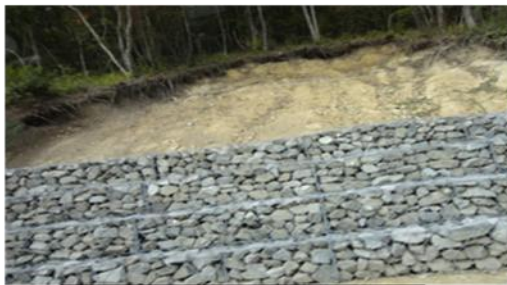
Down south, along route 445, between landslide site #2 and #4, gabion walls were seen erected on the western side of the highway to hold the near-vertical slopes and prevent slope failure.

Fig 4: Gabion Walls at site #2

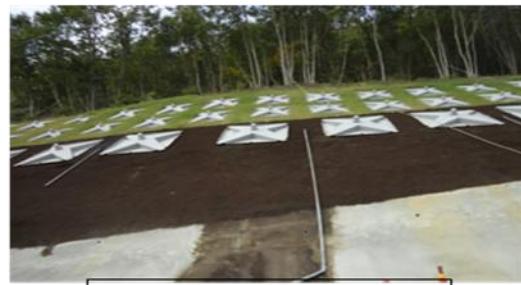
Fig 5: Anchors, dowels and bolts

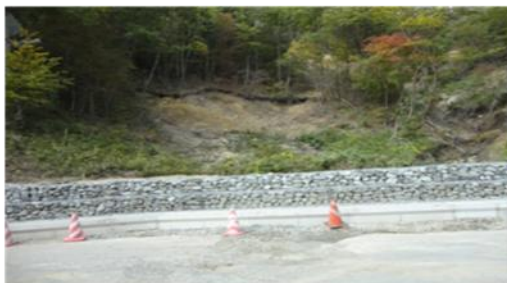
Fig 6: Gabion Walls at the Site #4

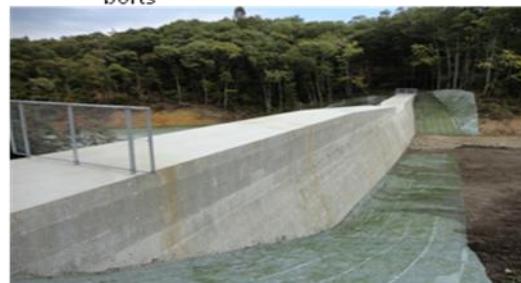
This was seen at Site #5. The landslide in this site has the longest length. The associated debris flow was said to cross the major road and continued downstream. No fatality or

damage was recorded because the area was covered by vegetation. Length of the Check dam was measured to be 85.5m while height is 10m. Total volume of the dam is 3957.4m³.

Fig 7: Check Dam at Site #5

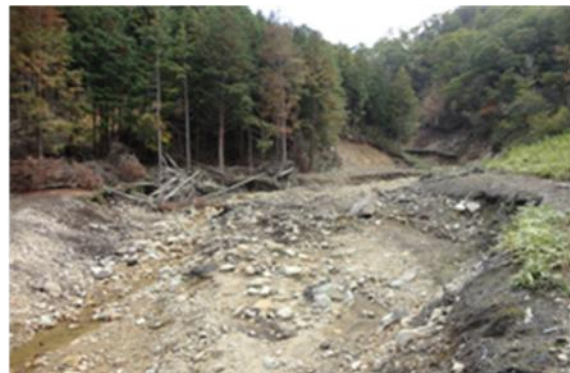
Fig 9: Upstream face of Site #5 showing tree stumps and cleared debris path

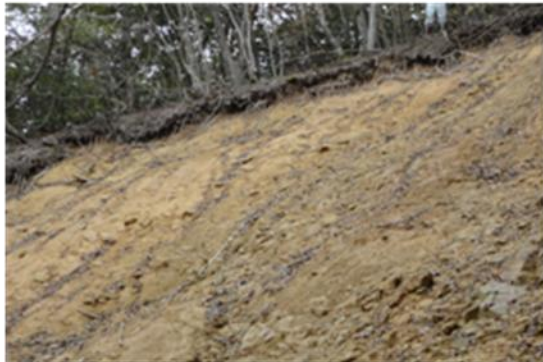
Fig 10: Head scarp of Site #3

Alas! We made it to the head scarp. I remember sticking my hands on thorny weeds at the same time hearing my professor beckoning on me to keep it steady! From the head scarp down-slope, the length of the slope surface was estimated to be more than 4km. I also saw my professor using his compass to take some readings which I presume might be slope angle, distance, and elevation.
