Analysis on the mechanism of landslides triggered by impoundment of water reservoir and development on the deformation prediction method

Fawu WANG (Kyoto University)

Abstract

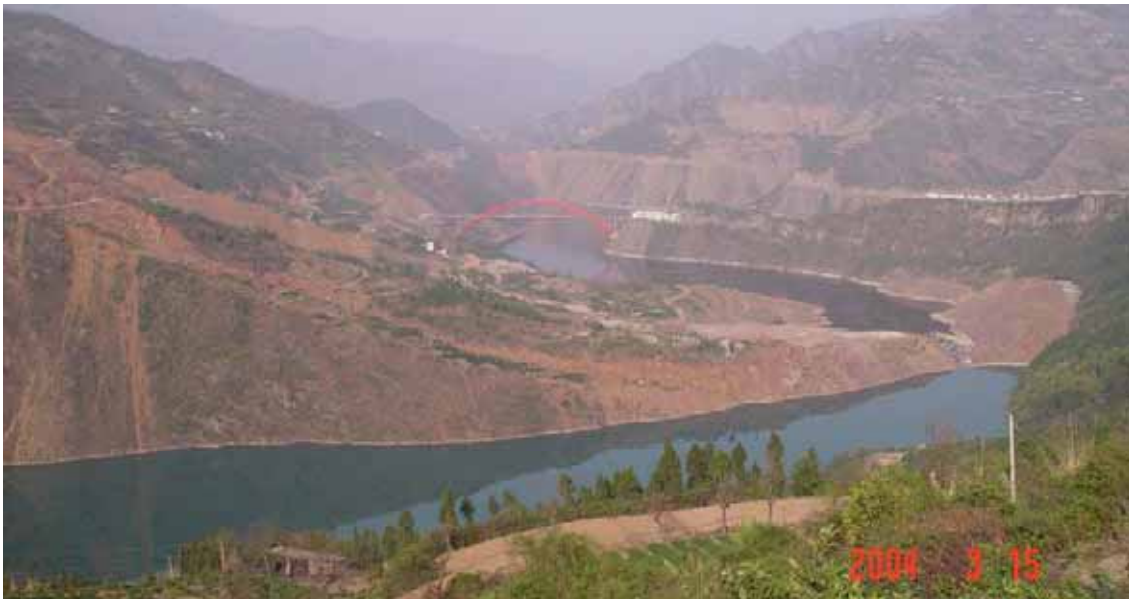
Figs. 2 and 3 are photographs of the landslide taken from the upstream side and front of the landslide. The landslide had a tongue-shaped plan, with a length of 1,200 m, and a width of 1,000 m. It moved about 250 m in the main sliding direction of S45°E. The average thickness of the sliding mass was about 20 m, thinner in the upper part and thicker at the lower part. The total volume was estimated to be more than 20 million cubic meters. The elevation of the main scarp was 450 m, and the elevation of the Qinggan-he River water level was 135 m when the landslide occurred. The landslide release surface was along a bedding plane in the bedrock (Fig. 2). Factory buildings on the sliding mass still remained standing after sliding for about 250 m (Fig. 3). However, because serious cracks developed in the buildings, they could not be used

Fig. 2 View of the Qianjiangping landslide from the upstream side of Qinggan-he River (Taken by F.W. Wang, March 15, 2004)

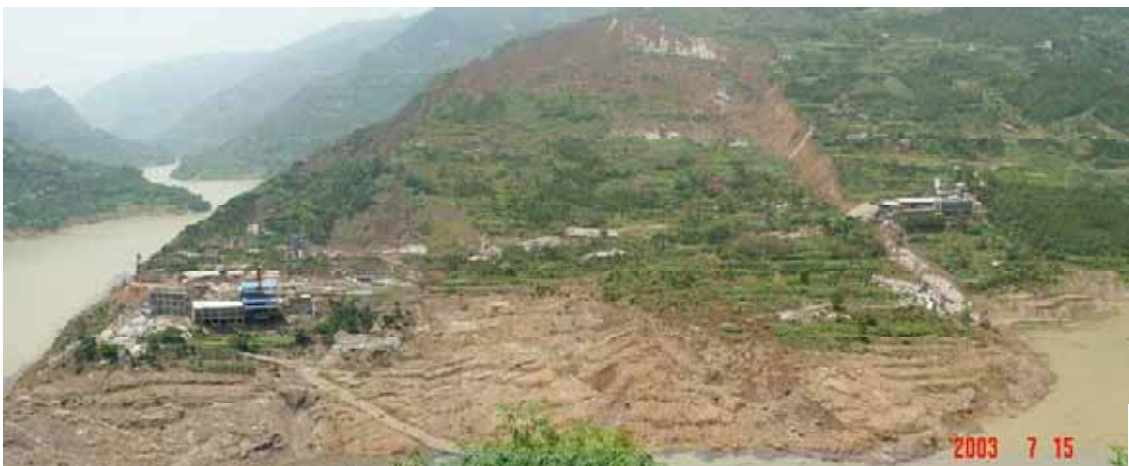
Fig. 3 Front-on view of the Qianjiangping landslide (Taken by Y.M. Zhang, July 15, 2003)

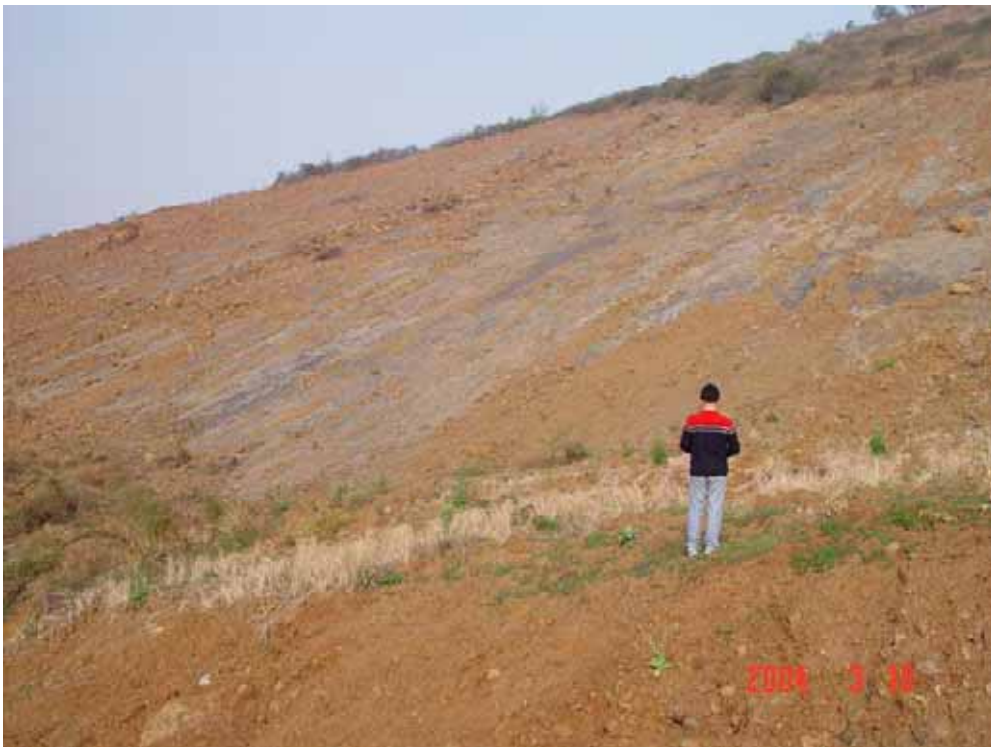
Fig.5 The exposed planar sliding surface, which is also a sandstone-bedding plane (there is a damaged rice paddy in front of the person)

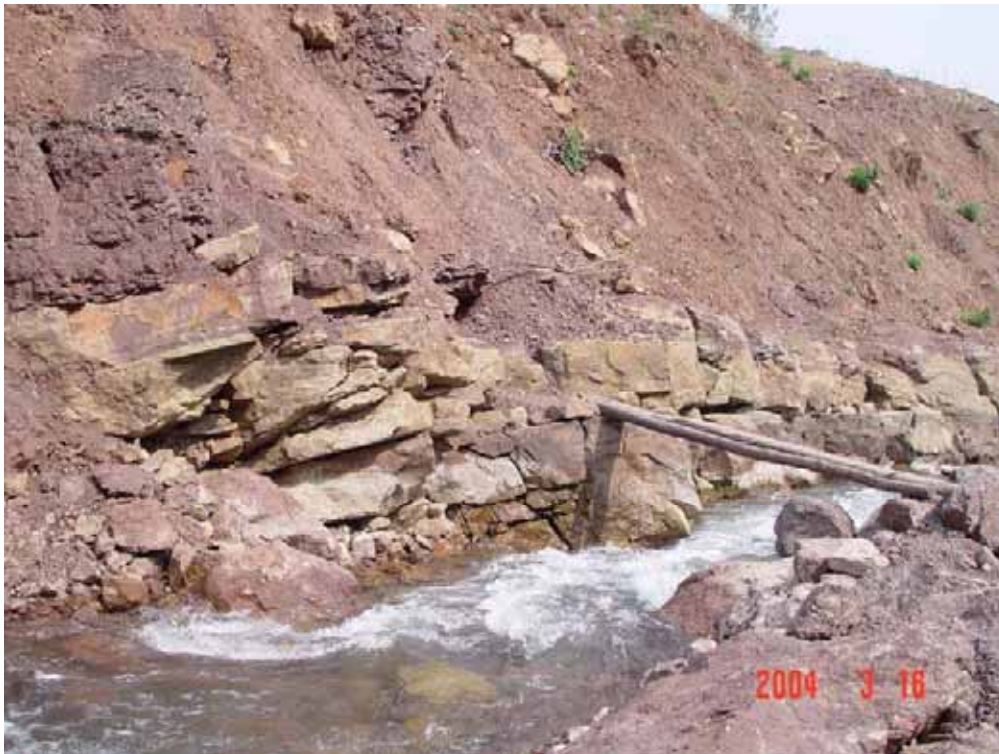
Fig. 6 View of the reversed dip direction of the sandstone beside Qinggan-he River (Taken by F.W. Wang, March 16, 2004)

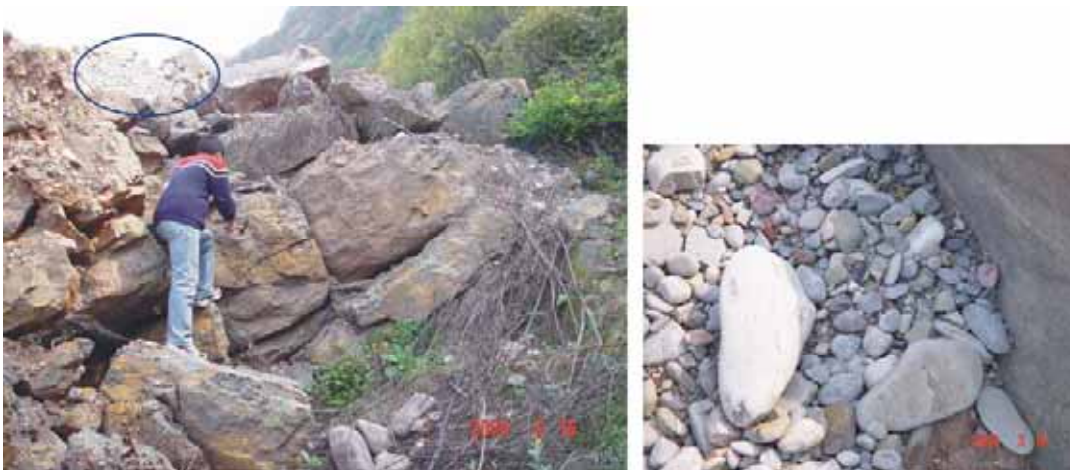
Fig. 7 Gravels displaced from the bed of Qinggan-he River and deposited in the toe of the landslide deposit (circled in photograph). Note that the sandstone dip direction is reversed and the dip angle has become steeper compared with Figs. 4 and 5)

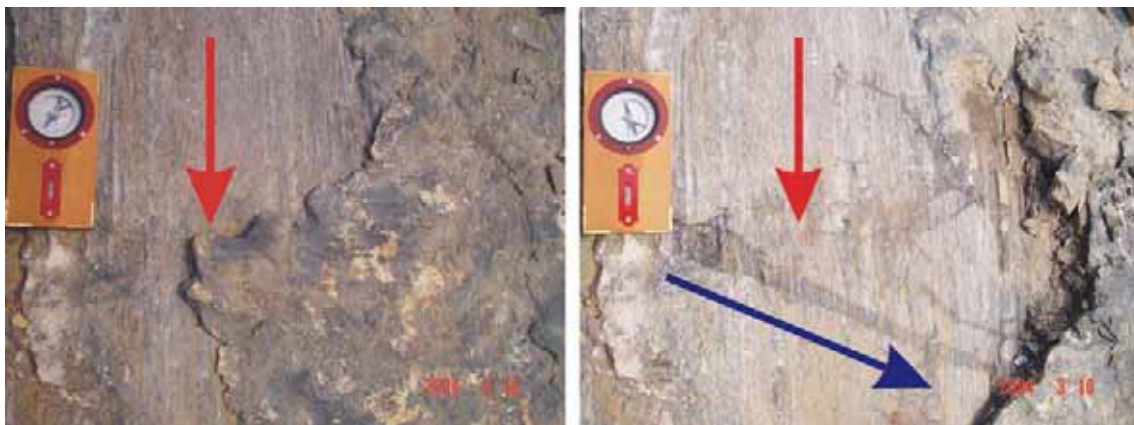
Fig. 8 shows a sequence of two photographs of scratches on the sliding surface at the upper part of the landslide. Fig. 8a shows the original situation, while in Fig. 8b a slice of sandstone has been stripped away from the plane to reveal more scratches. This shows that the scratches were present beneath the landslide sliding surface before the landslide occurred. The scratch strike direction is S15°W (red arrow). The sliding direction (S45°E) of the July 2003 event (blue arrow) is also shown by the water dribble trace in Fig. 8b). The angle between the sliding direction and the scratches is about 60°. Comparison of the two photographs shows that the scratches were not formed by the event of July 2003. They must have formed earlier, probably in a much older geological event, because calcite veinstone is widely distributed along them. This site lies between the Zigui syncline and Baifulai-Liulaiguan anticline that were folded during the Cretaceous period (Wang et al. 2002) and so the scratches can be interpreted as slickensides along bedding-plane shears.

Fig.8 A pair of photographs at the same site showing the pre-existing scratches that underlie the sliding surface of the July 2003 event (Blue arrow shows the sliding direction, red arrows show the strike direction of the pre-existing scratches). The scratches are inferred to be slickensides formed by bedding-plane shear during folding of the rocks in the Cretaceous period

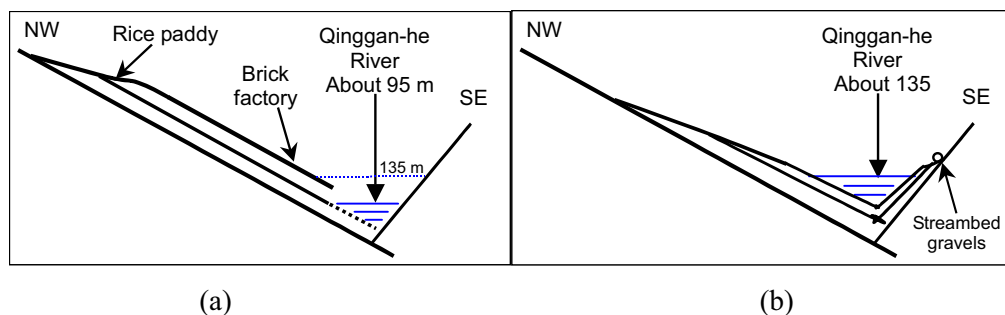
Fig. 10 Structural model of the Qianjiangping slope (a) and a sketch of the landslide after failure (b)

simplified as a two-dimensional longitudinal section as shown in Fig. 10(a). The situation of the landslide after failure is sketched in Fig. 10(b).

With the slope in a critical state (Fig. 10a), an increase in water level in the river would decrease the effective normal stress in the toe of the slope, and the shear resistance would decrease at the same time. These changes in the mechanical balance resulted in the slope failure.

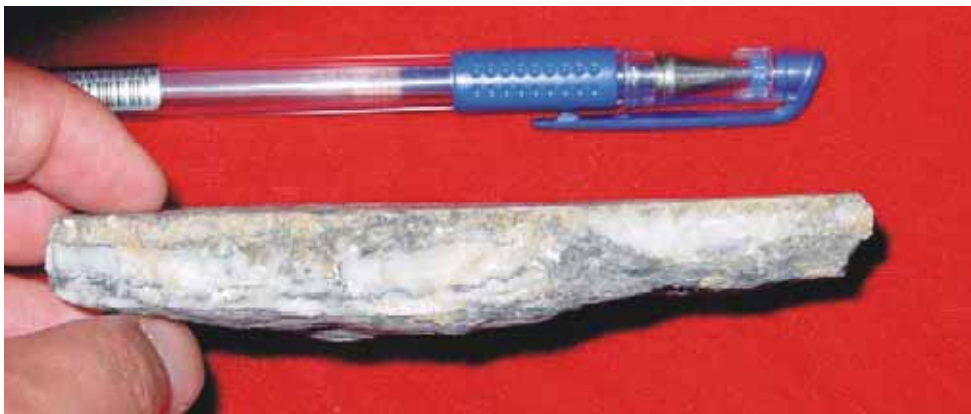
When the existence of the widely distributed scratches on the sliding surface is considered, it is easy to assume that the shear strength between the sliding mass and the sliding surface was at residual strength. If this assumption were true, the rapid, long-runout sliding would be difficult to explain, because a rapid loss of shear strength is necessary to achieve the high rate of acceleration. As mentioned previously, the scratches probably were formed in the Cretaceous period, and the beds on either side of the scratched surface were bonded together with calcite cement. After the occurrence of the landslide, Zhang et al. (2004a) observed crushed crystalline calcite, some 20 to 30 mm thick, widely distributed on the exposed sliding surface on the upper part of the landslide. Fig. 11 shows a sample of the calcite. Generally, failure of crystalline calcite is characterized by brittle fracture. After a certain small distance of shearing, the cement bonding would have been destroyed. The quick loss of adhesion of the crystalline calcite could be the main reason for the rapid landslide acceleration after the initial failure of the slope.

Fig. 11 Photograph of a crystalline calcite sample taken from the sliding surface at the upper part (The white color is crystalline calcite)

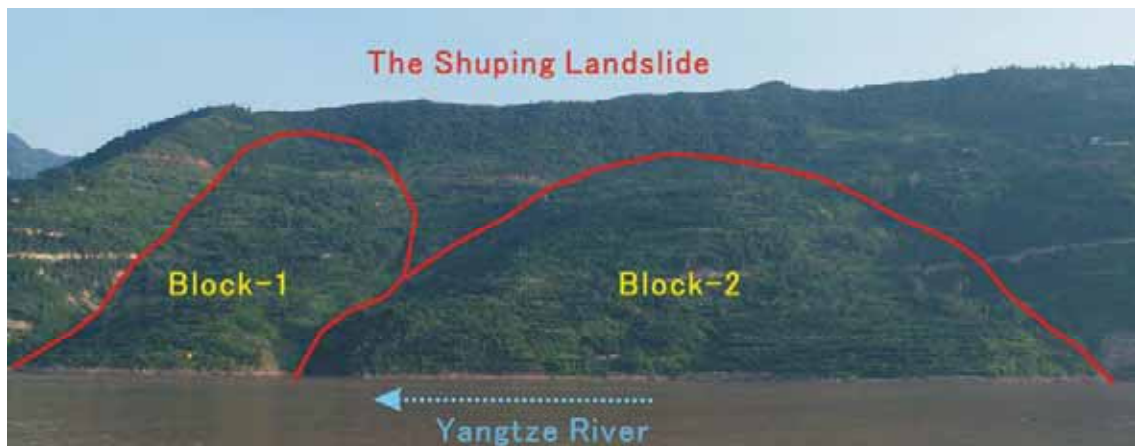
Fig. 12 Shuping landslide consisting of two blocks at the main stream of the Three Gorges Water Reservoir

The Shuping landslide is an old landslide which composed of two blocks. This can be confirmed in the photograph (Fig. 12). After the first impoundment of the Three Gorges reservoir ended on June 15, 2003, obvious deformation phenomenon appeared at the slope, and it became intense from February 8, 2004. Also, the two blocks shows different deformation rate at slope surface. The serious deformation situation made 580 inhabitants and 163 houses in danger directly, and all of the inhabitants were asked to live in the disaster prevention tents which were provided by the central government. Until May 2004, most inhabitants moved their houses out of the landslide area.

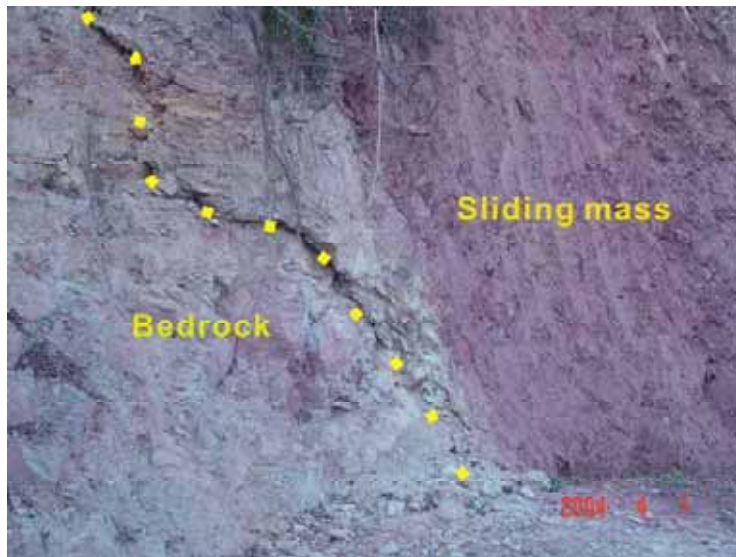
Fig. 14 shows a crack at the right boundary of Block-1 outcropped at a local road. The right-hand side is the sliding mass consisting of red muddy debris of old landslide, and the left-hand side is bed-rock of sandy mudstone, muddy siltstone of Badong formation of Triassic period (T3b).

Fig. 14 Crack at the right boundary of Block-I outcropped at a roadside

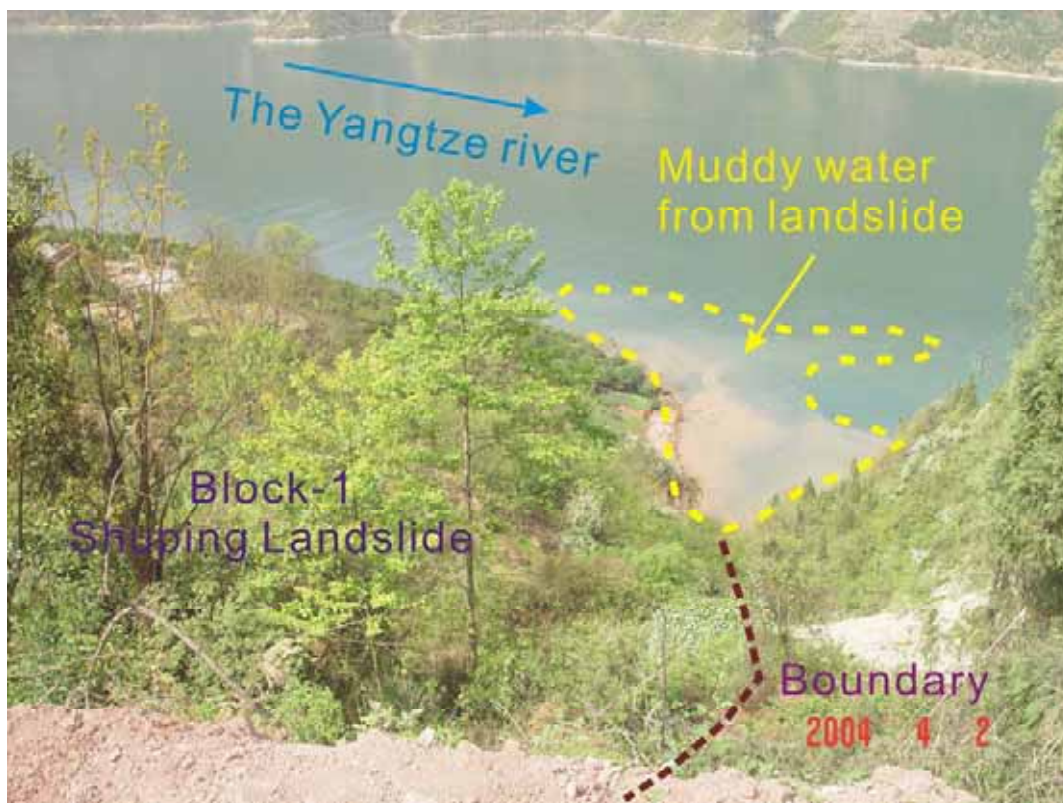
Fig. 15 shows muddy water coming from Block-1. It appears at the river even at continual sunny days showing no relationship with surface water erosion, but the underground water erosion from the inner part of the landslide.

Fig. 15 Muddy water seeped out of the toe part of the Shuping landslide

muddy. From March, the muddy water appeared almost everyday. Fig. 15 shows the muddy water situation in April 2004. This phenomenon is a very dangerous sign for slope deformation, because it may mean that the newly sheared soil at the sliding surface was eroded by underground water gradually.

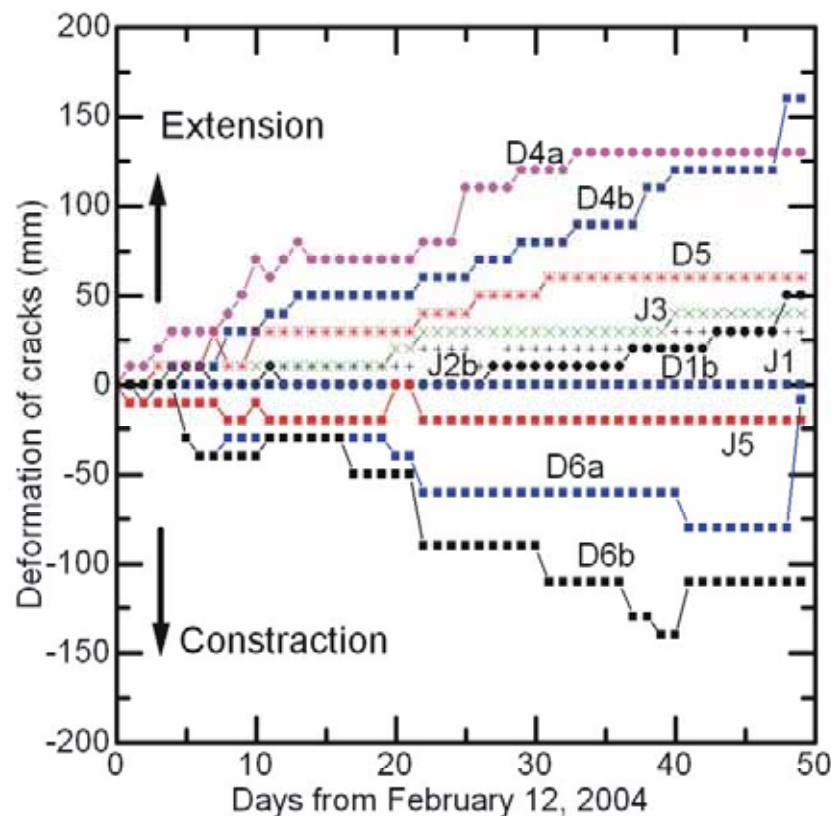
Fig.16 Measured results of crack deformation in Block-I

Roughly, the measurement results of the crack deformation shows that the extension behavior occurred at the boundary and inside landslide, and contraction deformation occurred at the other parts in the landslide block. For the 50 days period from February 24, 2004, the maximum displacement including extension and contraction respectively reached about 140 mm, showing an active deformation.

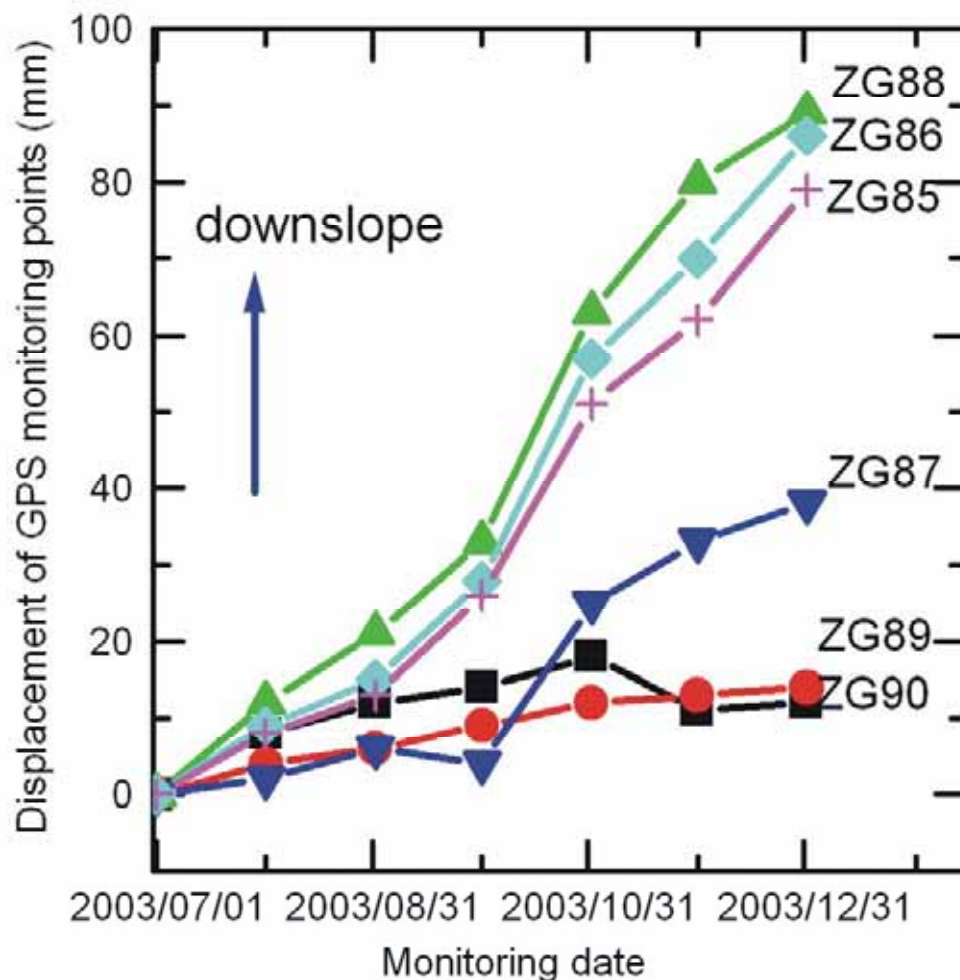
Fig. 17 GPS monitored results along the central section lines of Block-I and Block-II

Fig. 17 shows the monitored results of the GPS monitoring at the first six months after the impoundment. The displacement rate of Block-I increased rapidly after October 2003, and other two tendencies are also very clear. (1) The displacement at the lower part is larger than that at the upper part, this may be caused by water buoyant of the impoundment of the reservoir; (2) The displacement of Block-I is more active than Block-II, showing that the two blocks are independent from each other.

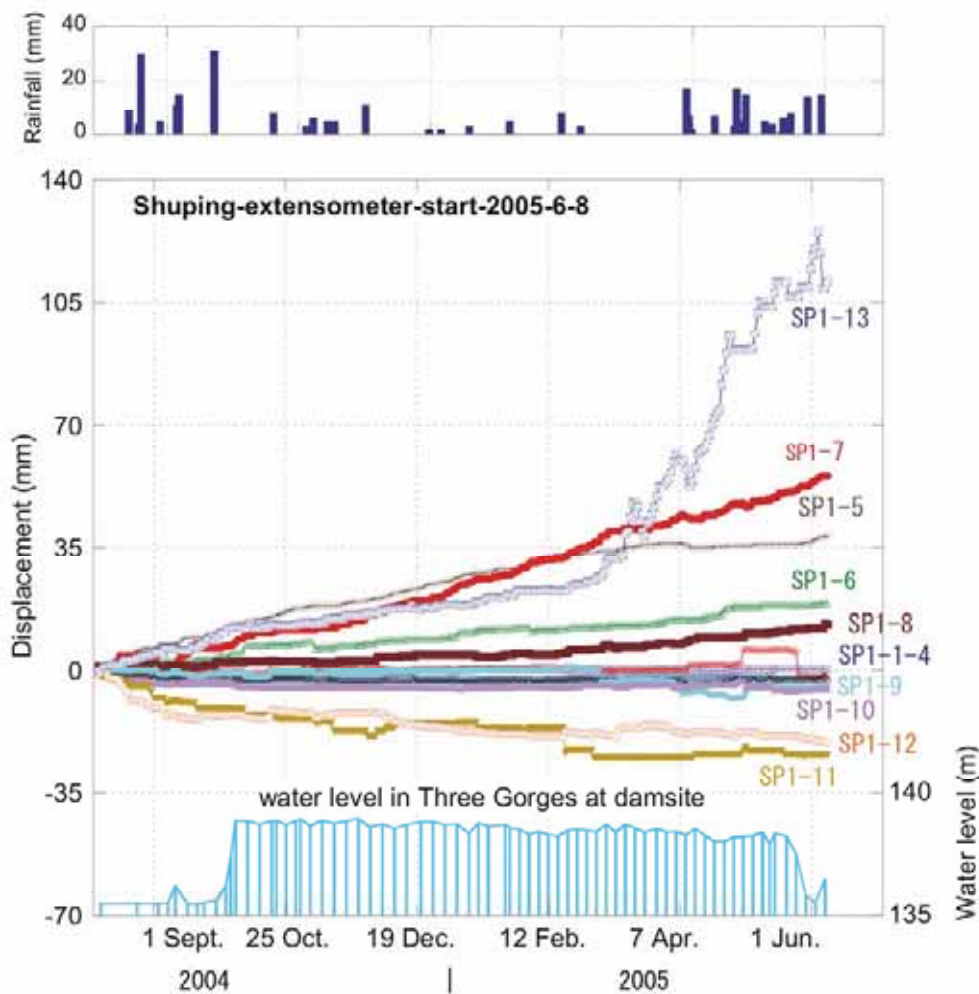
The monitoring results show some tendencies of the landslide displacement. (1) The SP1-1 and SP1-2 at the main scarp did not record obvious displacement. One possible reason is that the setting positions of the two extensometers did not cross the main scarp. (2) The deformations at SP1-5, SP1-6, SP1-7 and SP1-8 were the most active ones showing extension. Because of local failure, the SP1-13 showed extremely great extension. (3) The toe part of the landslide showed compression behavior. Comparing with the largest displacement at the lower part by GPS

Another important tendency was recorded in the monitoring results. In mid-September, the water level of the Three Gorges was raised for about 3 m, corresponding to this water level raising, the displacement velocity of SP1-5, SP1-6 and SP1-7 increased obviously, reflecting the influence of the impoundment on the slope deformation. Also, during the rainy season after April 2005, displacement acceleration tendency at some point (SP1-6, 7, 8) was monitored, showing the displacement of the landslide is also influenced by groundwater conditions.

Fig. 19 Monitored results of the extensometers (middle), the precipitation data in Yichang City (top) and water level in the Three Gorges Dam site (bottom)

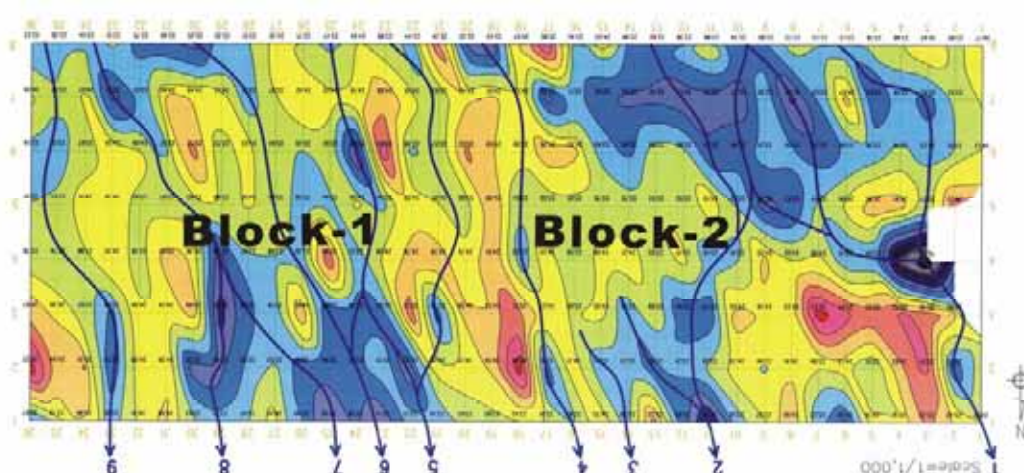
1m-depth ground temperature measurement was conducted to detect the groundwater veins in the lower part of the Shuping landslide. The measured area was shown as a square in Fig. 13. Fig. 21 is the measured results. From the ground temperature distribution, two independent groundwater vein groups were estimated existing in Block-1 and Block-2. The exit of the groundwater vein in Block-1 is lower than that in Block-2. It is estimated that the groundwater veins No.8 and No.9 correspond to the muddy water seeped from Block-1.

Fig. 21 Groundwater veins distribution estimated from 1m ground temperature measurement

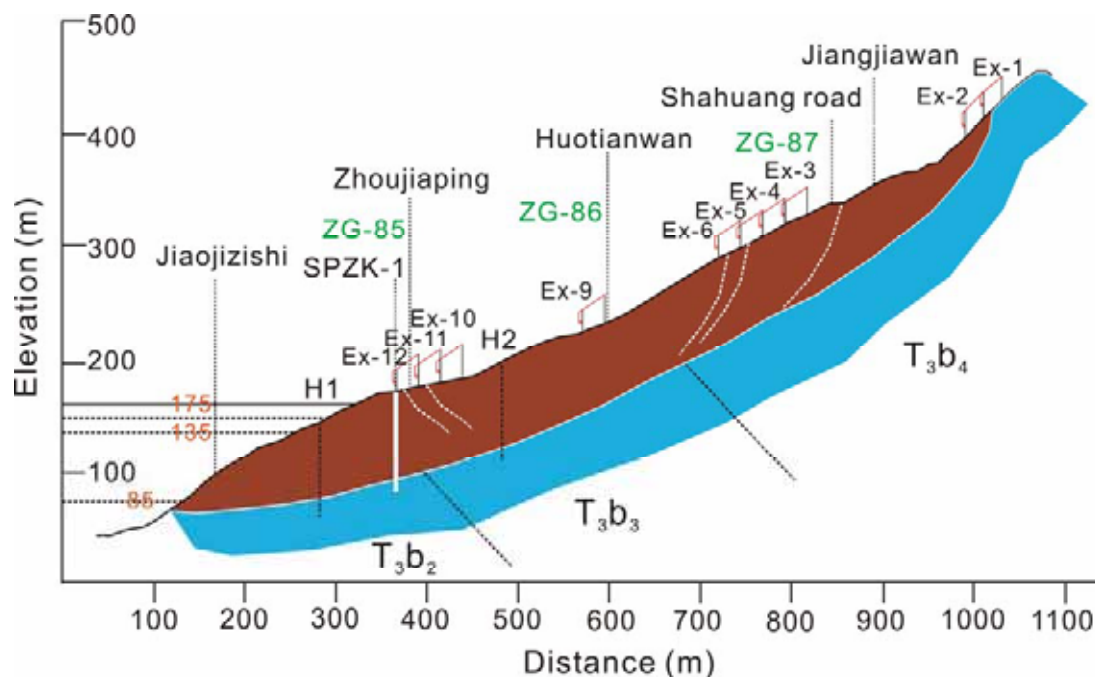
Through the GPS monitoring, crack displacement measurements, extensometer monitoring along the longitudinal section of Block-1, the deformation style of the Block-1 of Shuping landslide can be sketched as Fig. 23. Sooner after the impoundment of the water reservoir, the toe part displaced downward faster than the upper part. In the current stage, two years after the first impoundment, the slope deformation style changed. The displacement of the lower part almost terminated while the upper part displaced downward gradually, and compressed the toe part.

Fig. 23 Longitudinal section of the Shuping landslide
