Report of Field Trip to Shobara, Hiroshima

Date: Oct.28, 2011 - Oct.29, 2011

Debris Flows at Shobara

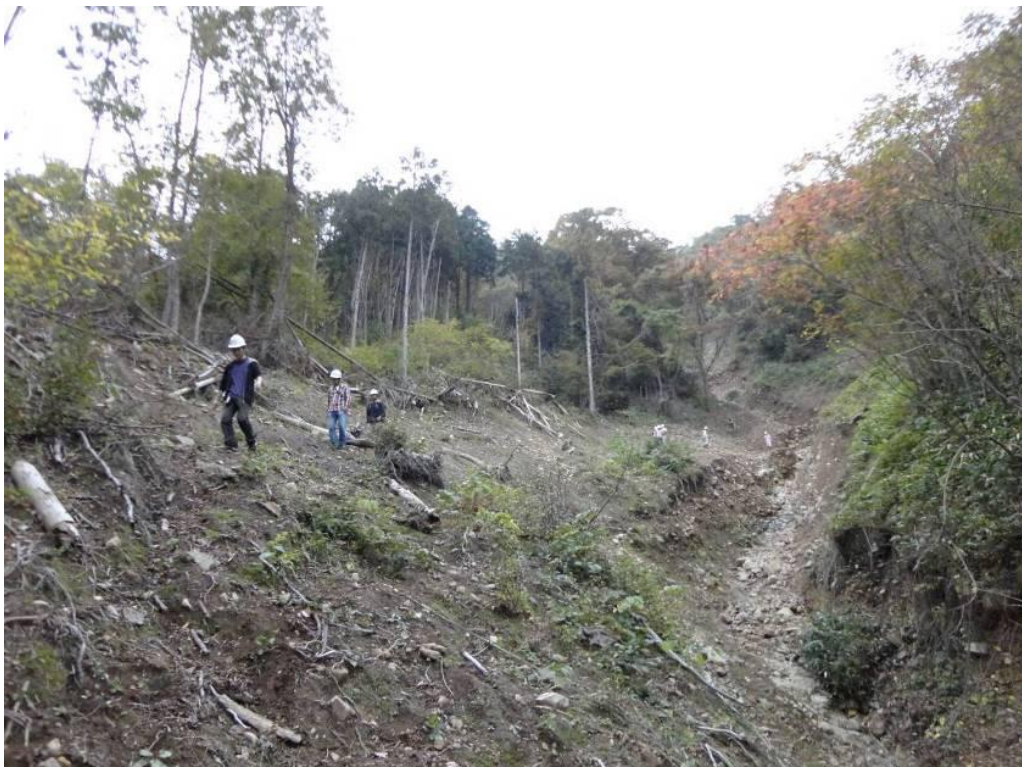
At July 16, 2010, massive debris flows occurred shortly after storm rainfall at Shobara, Hiroshima. Debris flows destroyed road, houses and vegetation nearby the gully. Unfortunately, this debris-flow hazard took one life when destroyed one house located at the foot of slope. The debris flows obtained most of their volume by scouring a mass of topsoil and channel bed, and destroyed extensive vegetation (Fig.1).

Fig. 1 A gully after debris flow that occurred at Shobara, Hiroshima, Japan

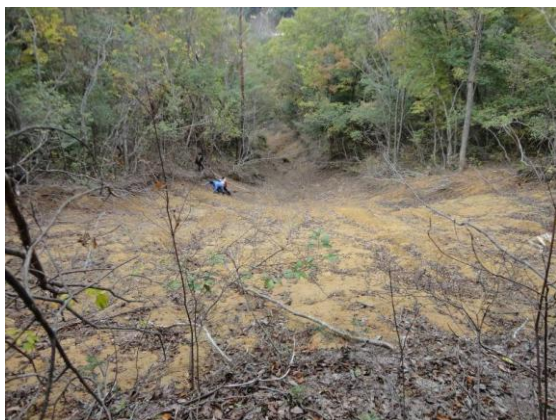
We investigated the source area of one channelized debris flow (Fig. 2). It is a translational shallow landslide. According to the exposed main scarp, the bedrock is

Fig. 2 View of debris flow area from the crown of landslide

Attentively, concentration of runoff from the storm mobilized talus and other debris in tributary channels and scoured material from the main channel into a debris flow, which maybe occur under next heavy rainfall. In addition, the flank of landslide forms the exposure face of topsoil. The topsoil should be partly failure under other triggering factors (heavy rainfall or earthquake) along the flank of landslide.

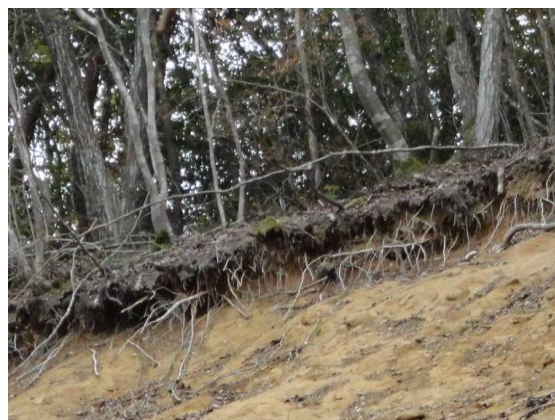
weathered andesitic rock. Topsoil layer located on the upper part of slope is thin, about 40cm to 100cm in thickness. This layer is composed of completely weathered andesitic rock, vegetation root system, and humus layer (Fig. 3). Various, topsoil layer located on the lower part of slope is thicker, about 1m to 1.5m in thickness. This layer is composed of pumice, volcanic ash, and humus layer (Fig.4). The flow path has a terrain with 30° to 45° degree slope.

Fig. 3 Topsoil layer located on the upper part of slope

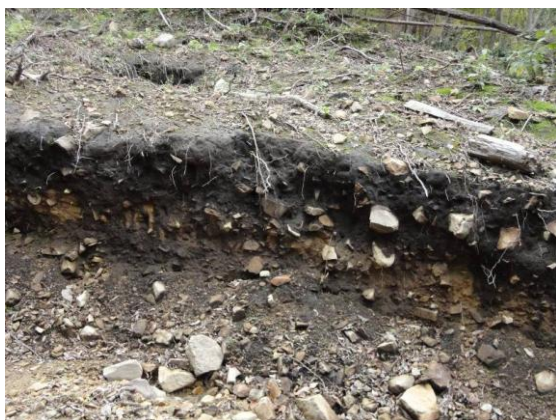
Fig. 4 Topsoil layer located on the lower part of slope

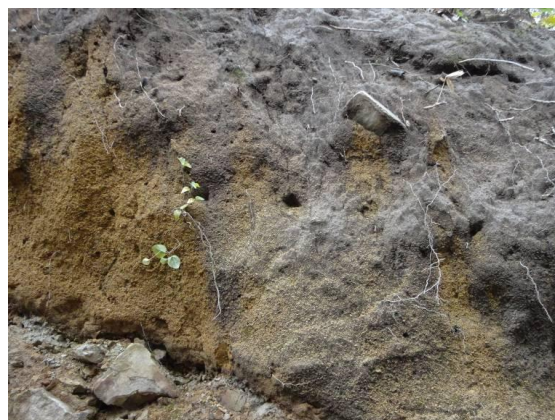
Undoubtedly, intense rainfall is the triggering factor. Before the occurrence of massive debris flows, the maximum precipitation is 91mm within one hour (Masahiro, 2011). The rapid infiltration of rainfall, causing topsoil layer saturation and a temporary rise in pore-water pressure, is believed to be the mechanism of this shallow landslide. Because the porous nature of topsoil layer located on the lower part slope, piping holes are visible under biggish hydraulic gradient (Fig. 5).

Fig. 5 Piping holes in the topsoil layer located on the lower part of slope

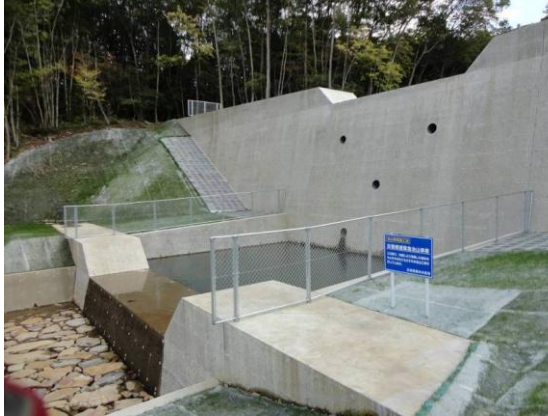
Fig. 6 Concrete Check dam with low-flow center section

At the mouth of valley, concrete check dams were built to store debris-flow sediment (Fig. 6 and Fig.7). Although concrete check dams are expensive to construct, they go a great way with controlling channelized debris-flow frequency and volume.

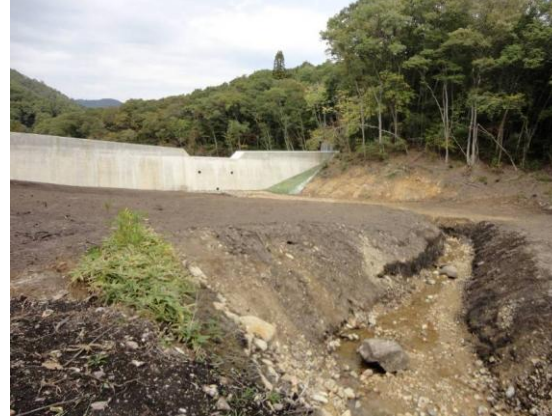
Fig. 7 Upstream view of a concrete check dam

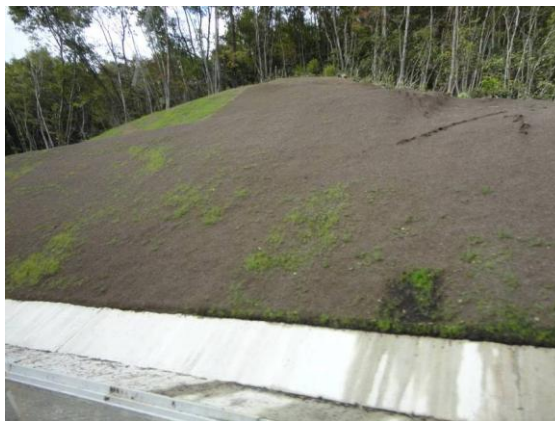
Fig. 8 Biotechnical slope protection

Biotechnical slope protection method was used along the road (Fig. 8). This type of seeding is the application of seed in water slurry that contains fertilizer, soil binder, and mulch. Seeding with grasses reduces surface erosion, which can under certain conditions lead to landslides. If not controlled, surface erosion and small, shallow slope failures can lead to larger problems that cannot be controlled.

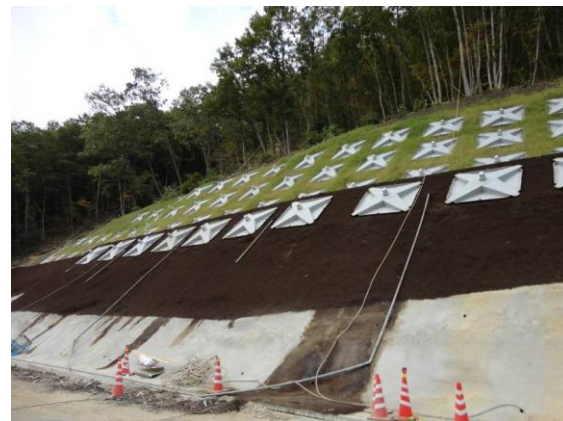
Fig. 9 Anchor & biotechnical slope protection

Compared with shotcrete, this type of slope protection can reduce the environmental consequences of landslide-mitigation measures, and is more visually pleasing and environmentally friendly. At some rock slope area, these are tools composed of steel robs or cables that reinforce and tie together a rock face to improve its stability (Fig. 9).

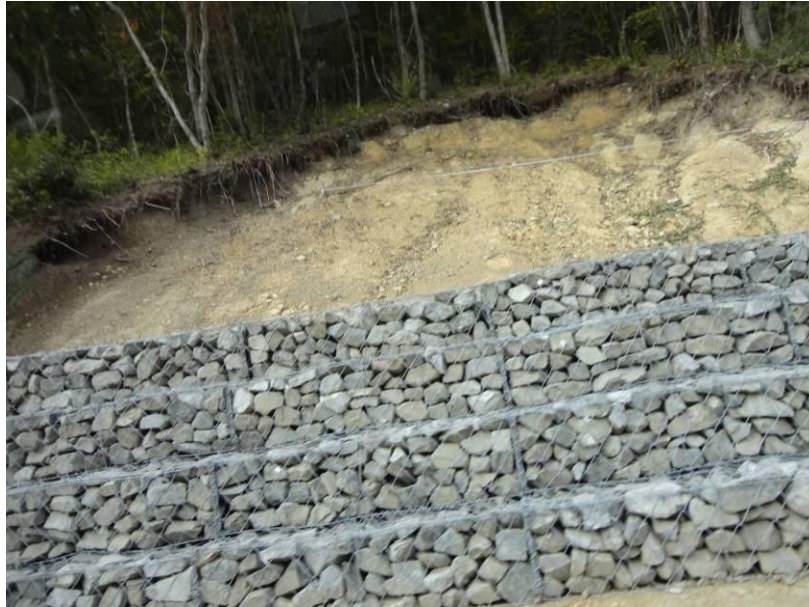
Fig. 10 Gabion wall along the road

Gabion walls were constructed at small-scale landslide area along the road (Fig.10). The gabion retaining walls were composed of stacked gabions which are wire mesh and boxlike contains filled with cobble-sized rock that are 10 to 20 centimeters size. Gabion walls are inexpensive and are simple and quick to construct. Because of their coarse fill, they are very permeable and thus provide excellent drainage.
