REPORT OF FIELD TRIP TO SHOBARA, HIROSHIMA, OCTOBER 28-29, 2011

The Shobara Landslide

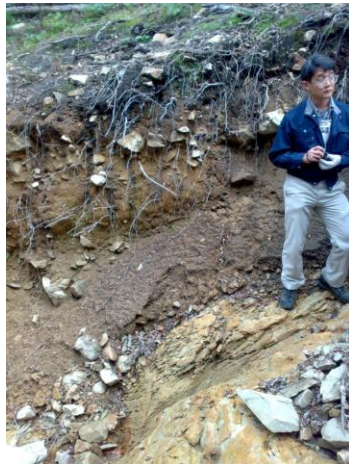
Shobara is the part of Hiroshima prefecture that has mountainous terrain with 35° to 45° degree slope. The geological condition of the region is mainly andesitic and rhyolitic rocks. From the scrapped ground of the flow path, the soil layers are revealed. The base layer is weathered andesitic rock that estimated as the landslide slip base. Above the base layer, there is some pumice layer with 50 cm to 75 cm thick. The top soil consists of andesitic fragment disrupted with decayed material about 30 cm to 1 m in thickness. The exposed soil layer can be seen in **Figure 2**.

Figure 2 Exposed soil layer

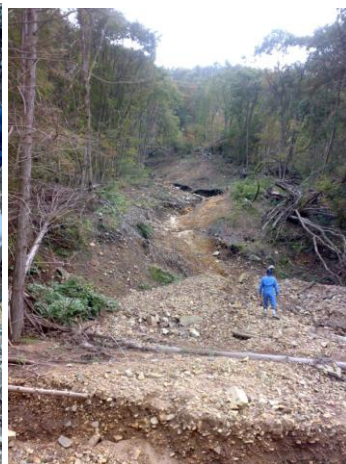
Many landslides occurred in Shobara, Hiroshima Prefecture on July 16 2010 during 2-3 hours of heavy rainfall which is considered as triggering factor the landslides events. The type of the landslides is commonly debris flow which has long path from the top to the base of the mountains (**Figure 3**). From the examined landslide source area, the landslide can be regarded to translational shallow landslide which has about 1 m to 2 m depth sliding surface (**Figure 4**). Generally, the landslides flow path have

Figure 3 Debris flow travel path

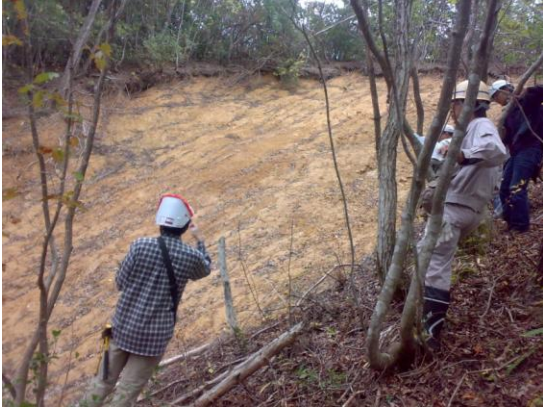
Figure 4 Debris flow source area

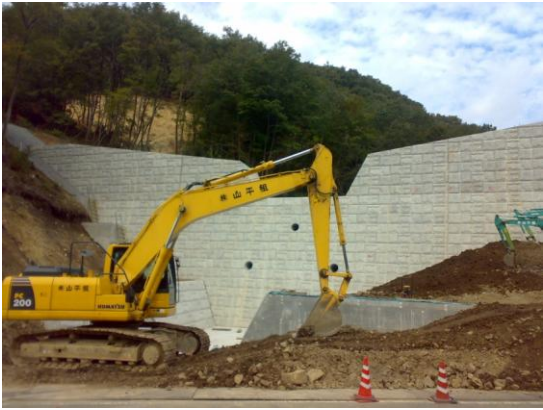
Some physical mitigation actions are already implemented surrounding the landslide prone area. Based on the purpose, one can concluded that there are two type of physical mitigation, there are: structures to avoid the impact of debris flow and structures to stabilize slopes. The first type of mitigation on the area is represented by sabo dam structure. Sabo dam is the massive structure that commonly using concrete material to retain the debris mass from landslide (**Figure 5**). The sabo dam is usually built by series depends of the potential debris mass that could happen in the future. Another type is represented by bolt anchored slope which is found the area (**Figure 6**).

Figure 5 Sabo dam structure

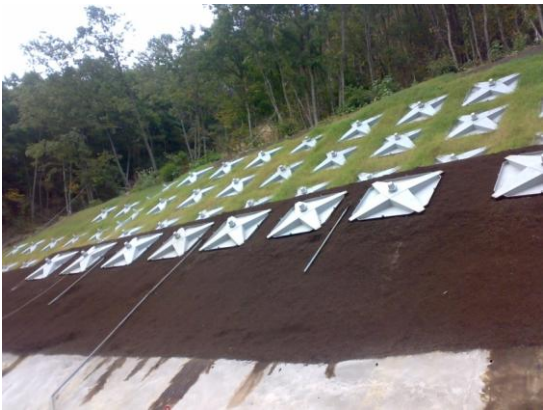
Figure 6 Bolted Anchor structure
