白山における甚の助谷巨大地すべり 突発災害の前兆現象および運動予測

研究成果報告書

平成18年3月

研究代表者 汪 発武
(京都大学防災研究所)

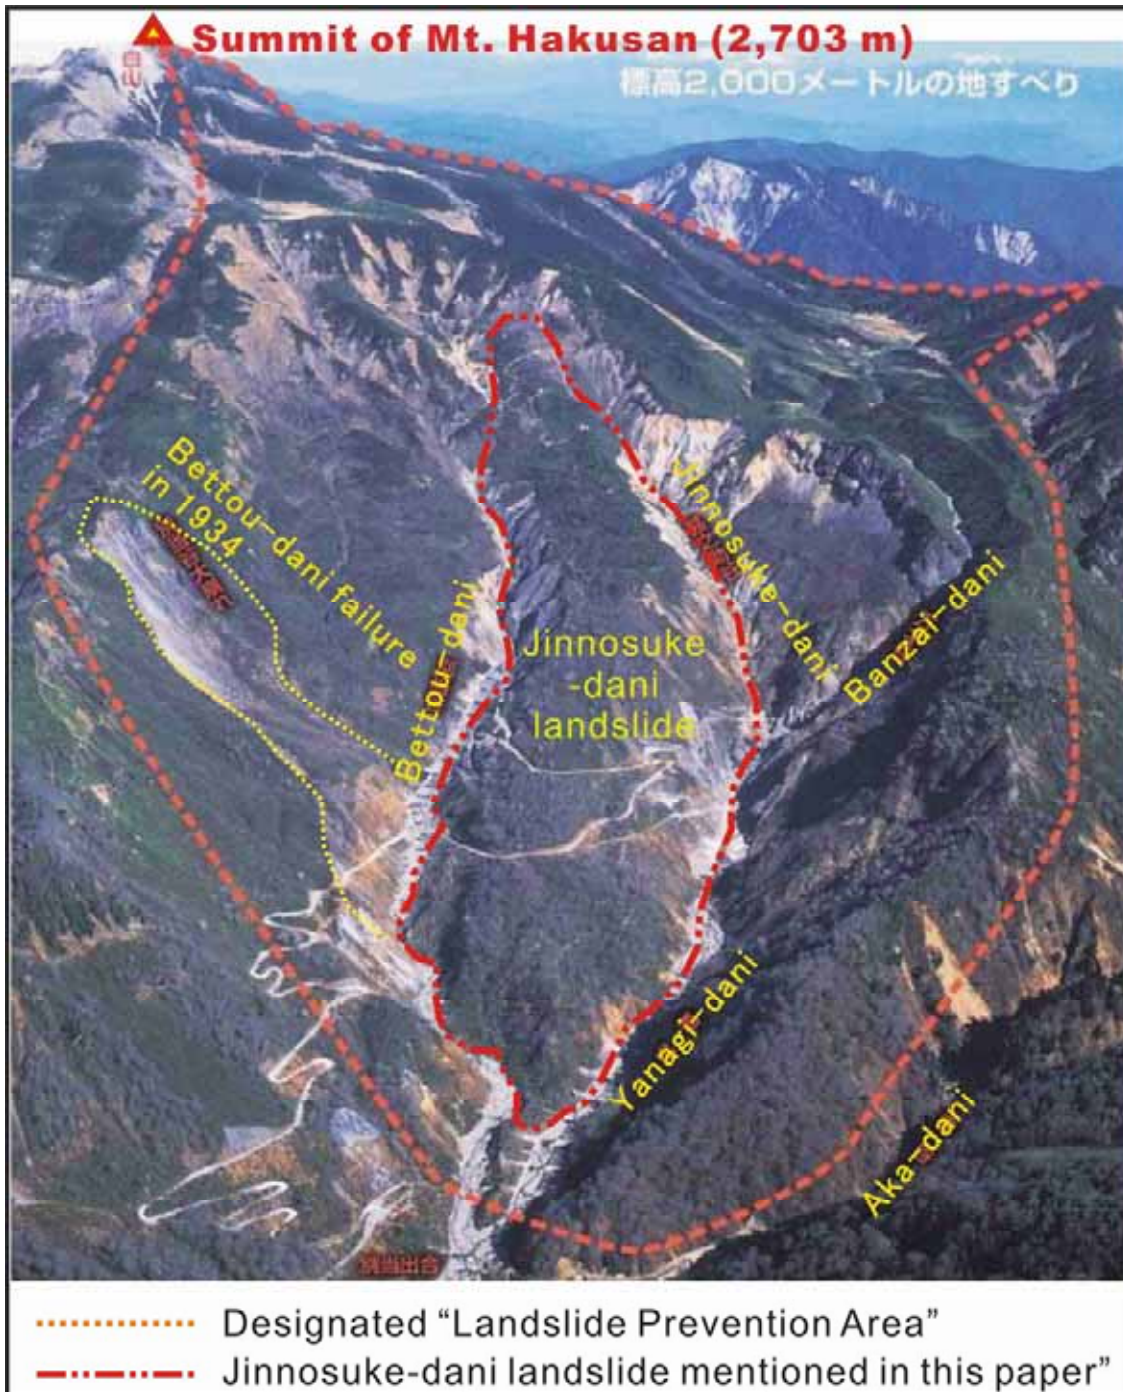
Fig. 2 Aero-photograph of the “Landslide Prevention Area” of the Jinnosuke-dani landslide (Photo Courtesy of Kanazawa Office of River and National Highway, MLIT)

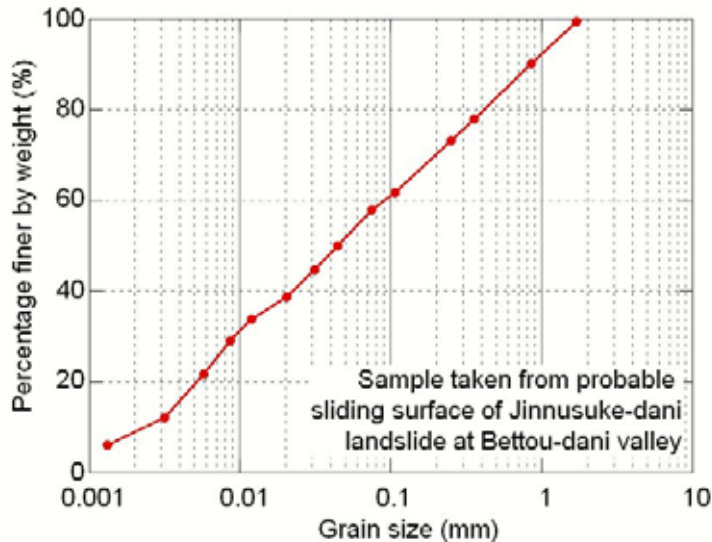
Fig. 11 Grain size distribution of the soil sample taken from the probable sliding surface of Jinnosuke-dani landslide at Bettou-dani valley

Fig. 11 shows the grain size distribution of the argillaceous shale. The fines content of the sample, including silt and clay, was 58%, the plasticity index was 8.3, the liquid limit was 20.1%, and the liquidity index was 0.99. This soil from the probable sliding surface was classified as “clay with low liquid limit”. Because the sandstone is highly jointed and this area is subject to heavy rainfall and snowfall, it may be conservative to assume that the shale in the alternating layers is always in a fully saturated condition, which is dangerous in regard to stability of the slope.

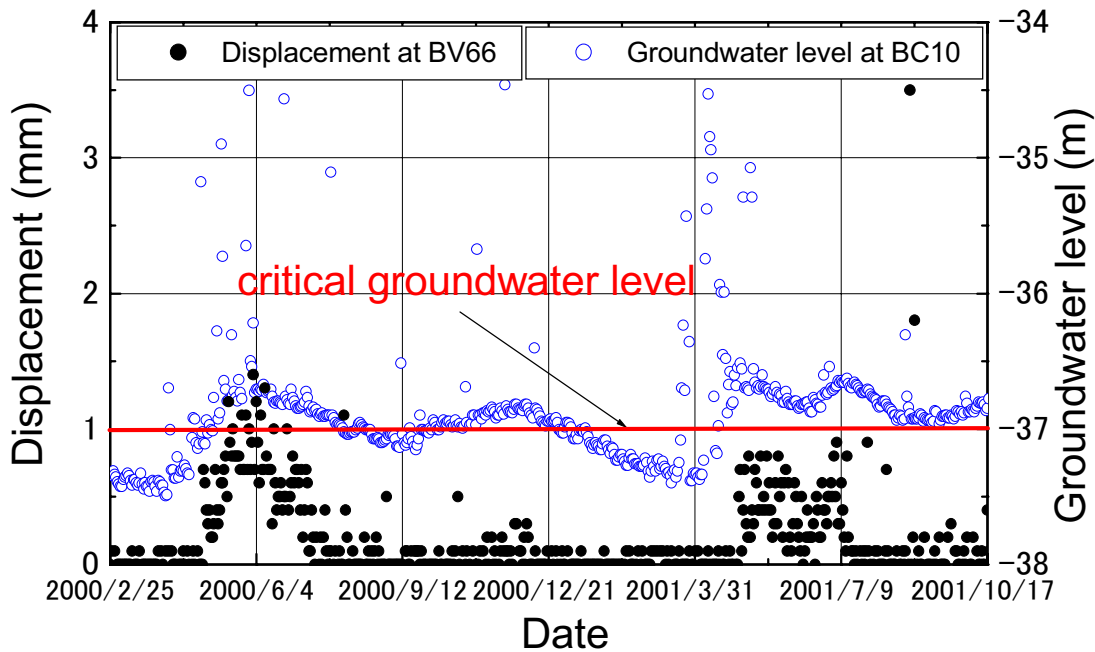
Fig. 20 Relationship between displacements measured at BV66 and groundwater level at BC10 indicating a critical groundwater level existing

Fig. 20 shows the relationship between displacement measured at BV66 and the groundwater level at BC10 from January 1, 2000, to November 18, 2001. The groundwater level started to rise in April and remained at a high level until the end of July, and it rose again at the end of October due to autumnal rain. Responding to the increased groundwater level, the landslide movement became active. In one cycle with a period of one year, the landslide movement accelerated from April to July, and then became dormant in winter. It was observed that the displacement started to increase when the groundwater level exceeded a depth of 37 m, which can be noted as the “critical groundwater level” at this position. When the groundwater level exceeded this critical level, displacement increased. The larger the height of the groundwater level over the critical level, the greater the landslide displacement. On the other hand, when the groundwater level became lower than this critical level, the landslide displacement stopped.

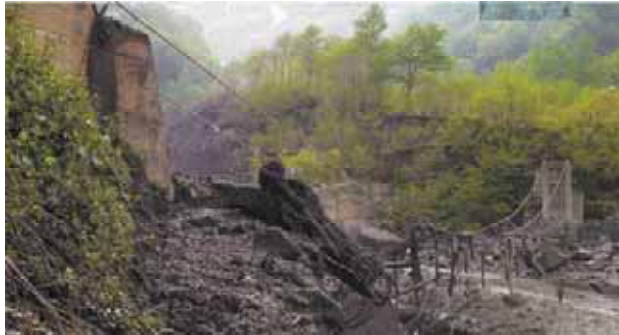
Fig. 6 shows the situation when the suspension bridge was completely destroyed. Large boulders 3-4 m in diameter were transported and deposited near the bridge site. Some thin debris was deposited on the top of the left pillar of the bridge, about 10 meters above the valley bottom. This shows that even near the terminus of the debris flow, the sliding potential was high and powerful.

Fig. 6 The suspension bridge that was completely destroyed by the May 2004 debris flow in the Bettou-dani (Photo courtesy of the Kanazawa Office of Rivers and National Highways, MLIT)

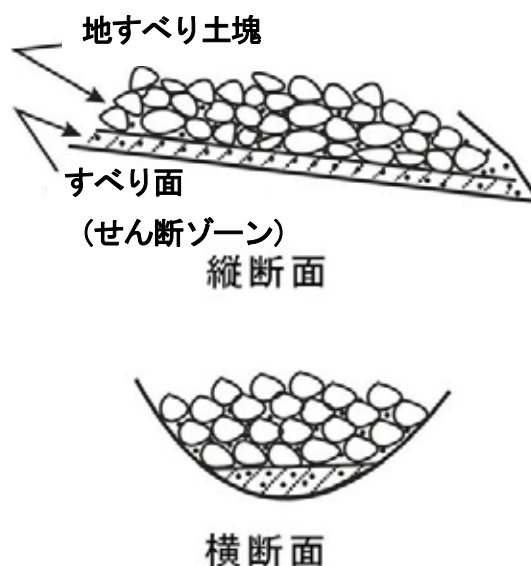
図-4 地すべりの2層構造

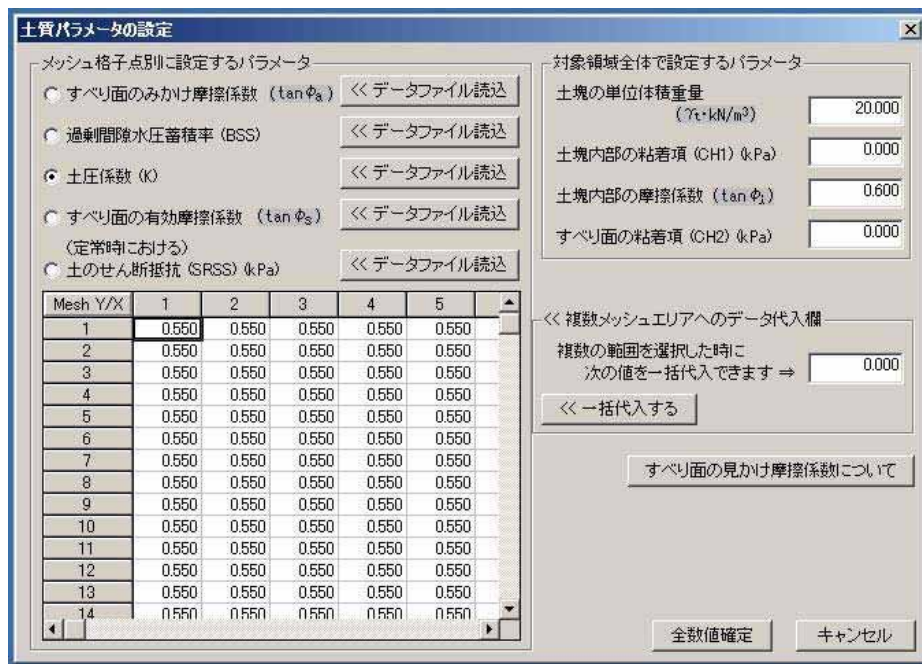
図-6 はシミュレーションのメイン実行画面で、右部分の画像はすべり面の状況を示している。図-7 はすべり面及びすべり土塊のパラメータの設定画面である。図-8 は計算過程の一部を抽出して計算時間順で表わしている。

図-7 地すべりシミュレーションのパラメータ設定画面

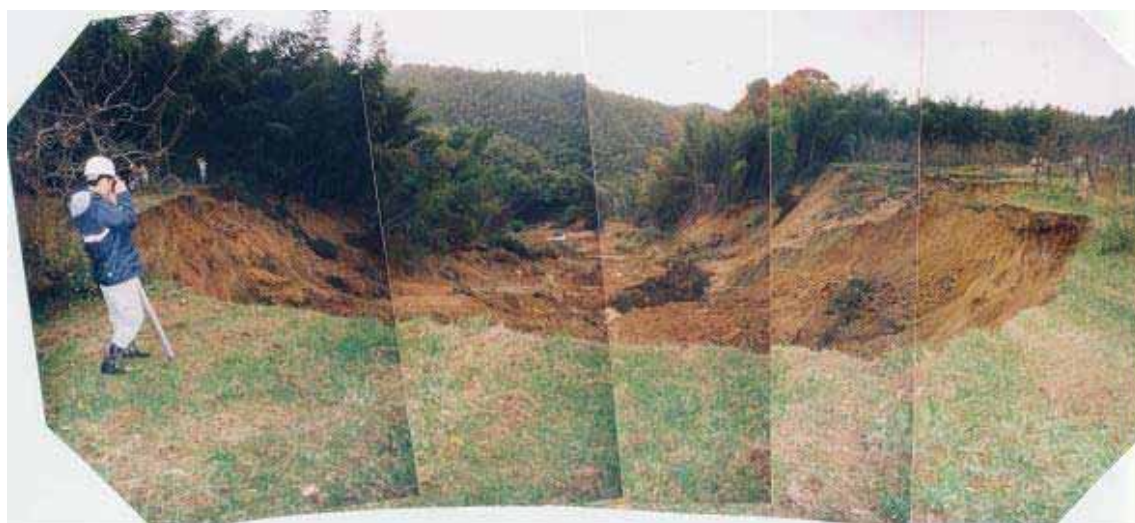
2002 年 11 月 8 日に, 石川県金沢市山科町で, 源頭部の幅約 60m, 長さ 100m, 滑落崖の高さ約 10m, 移動距離約 200m の流動性の山科地すべりが発生した (図-15)。この地すべりの誘因は発生前 13 日間の連続降雨であると考えられる。この地すべりによって源頭部でりんご畑が崩壊し, 末端付近で林道が決られ, 破壊された。地すべり発生後, 地すべりによる土石流被害を防ぐための砂防堰堤が末端部に建設された。その後も滑落崖での崩壊の拡大が続き, 2003 年 12 月 31 日には, 再び流動化地すべりが発生した。

図-15 金沢市山科町で発生した流動性地すべり (2002 年 11 月 8 日発生) (石川県県央農林総合事務所 提供)

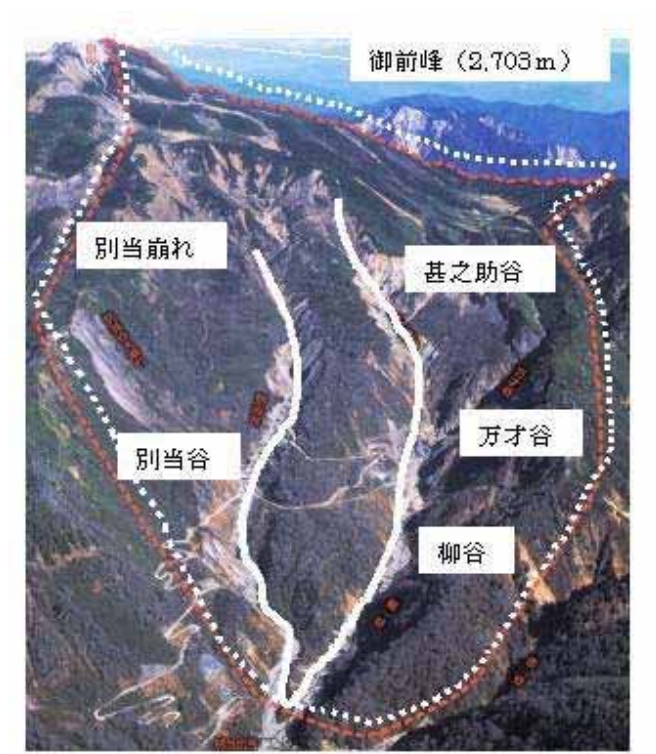
図-20 白山地域における別当崩れと甚之助谷地すべり

白山南西斜面（図-20）にある別当崩れは、1934年7月11日、3日間で500mmの豪雨によって発生した。崩壊した約1千万 m^3 の土砂は手取川の堆積物を巻き込みながら土石流となって、約4km下流の市ノ瀬村落を埋没させた。その後も手取川を流下経路として甚大な被害を及ぼし、ついには、約70km下流の日本海に到達した。この土石流によって死者112名、倒壊家屋240棟という甚大な被害をもたらした。

甚之助谷地すべりは図-20の写真中央に位置しており、長さ約2,000 m, 幅約500 mで、海拔1,200 m～2,100 mの間に分布している。右岸側は別当谷であり、1934年に発生した別当崩れの滑落崖が残されている。左岸側には甚之助谷（上流）と柳谷（下流）が存在している。土石流を防ぐために、1927年から現在までに、別当谷に約30基、甚之助谷と柳谷に約50基の砂防ダムが建設されている。

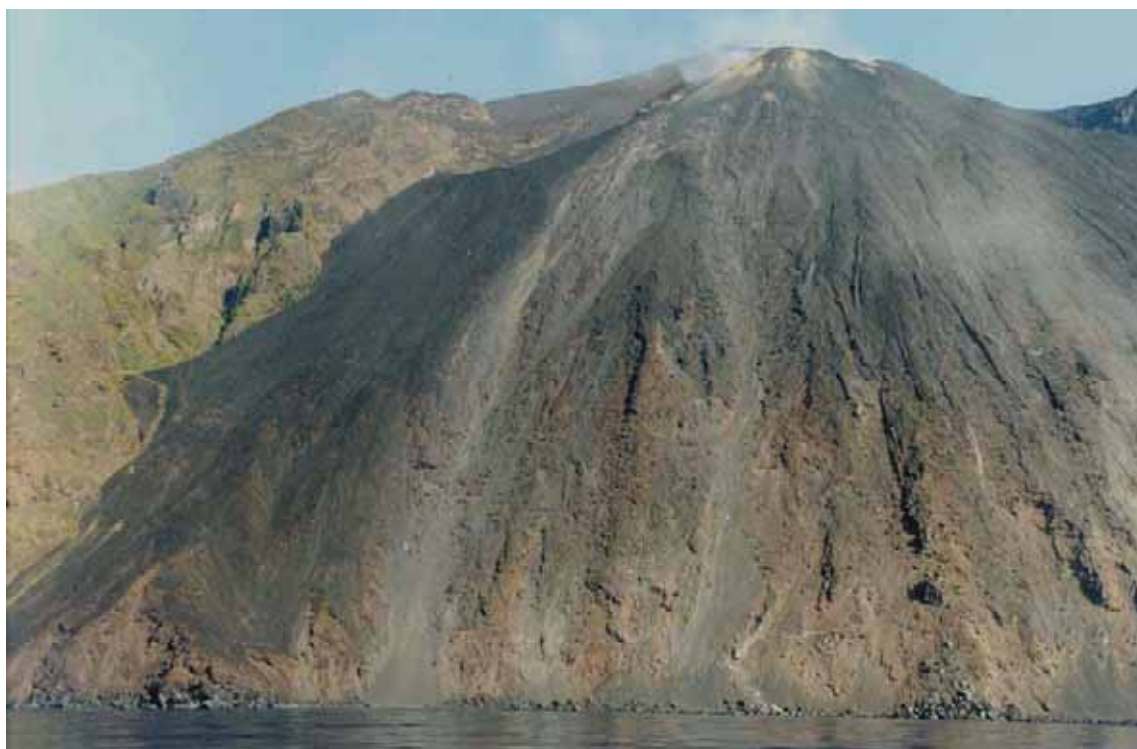
The island of Stromboli is the subaerial portion of a 4,000 m high volcanic edifice that rises for about 900 m above the sea level. The Sciara del Fuoco, hereafter called SdF or simply Sciara, is a scree slope, which collects the products of the persistent volcanic activity and drives them to the sea (Fig. 1). Actually, the Sciara is a depression originated by the last lateral collapse occurred after 5.6 ± 3.3 kyears b.p. (Tibaldi 2001), that is filled by a more than 200 m thick alternation of overlapping thick layers of loose volcanoclastic materials with minor layers of primary products (i.e. pyroclastites and lava flows).

Fig. 1 View of the Sciara del Fuoco before the 2002 landslides from the sea

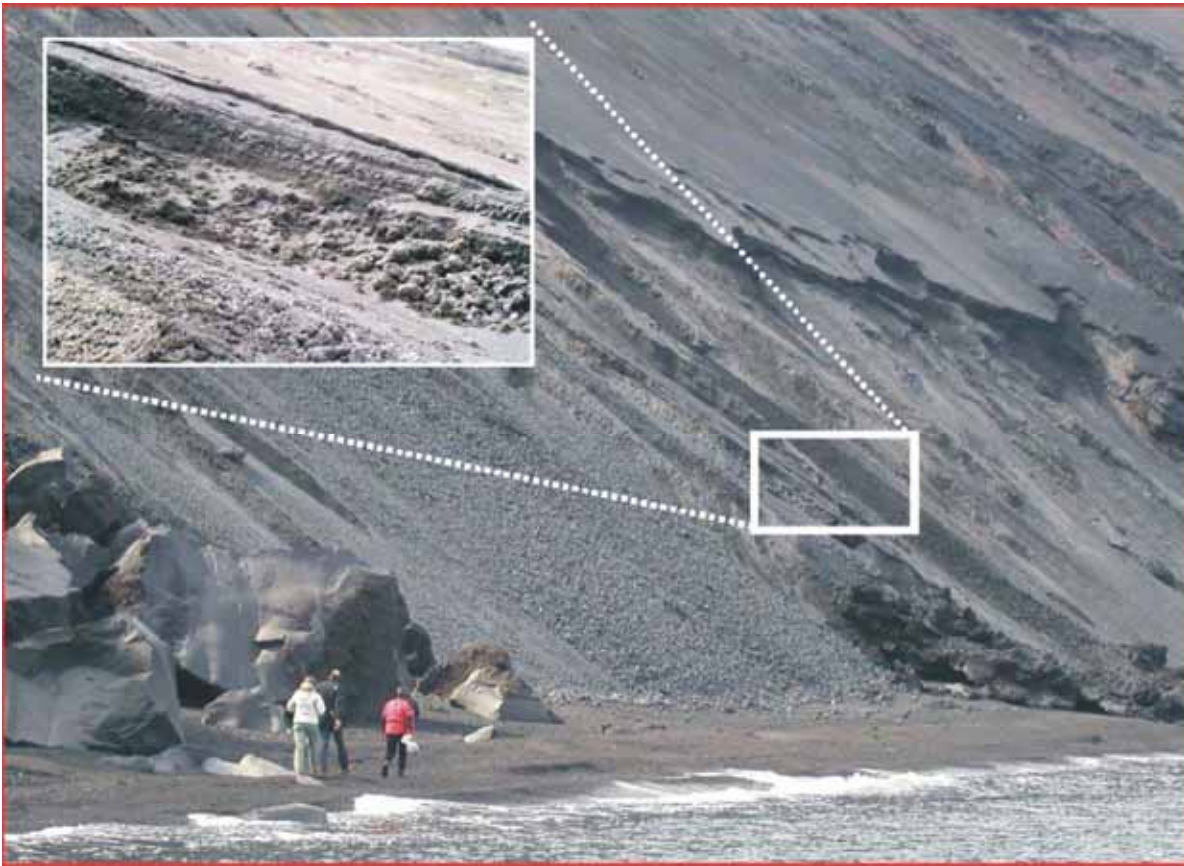
Volcanoclastic materials result from continuous sliding of primary products and their incessant redistribution over the slope by sheet slides and subsequent grain flows so as to produce a series of irregular, mostly reverse-graded grain-supported layers (Fig. 2).

Fig. 2 View of the Sciara foot after the 2002 landslides and detail of the volcanoclastic deposit (in the foreground the front of a major lava flow of the 1985 eruption)

The volcanoclastic material is mainly composed by gravelly and sandy layers (box in Fig. 2), which in the sampling area, have angular to subangular clasts with high surface roughness and low sphericity. Rounding, smoothness and sphericity progressively increase proceeding downslope, due to grain sliding and rolling (Kokelaar and Romagnoli 1995).

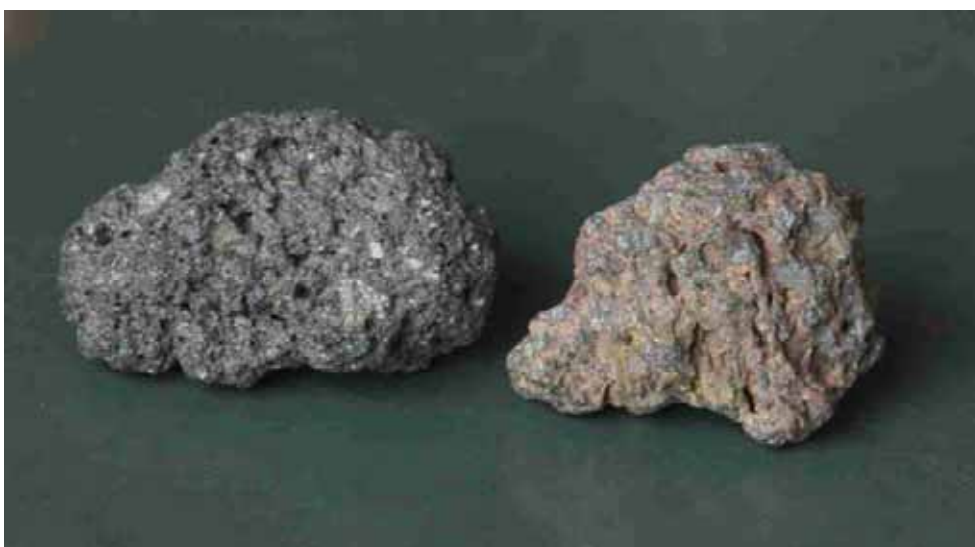
Fig. 5 Macrophotograph of black (on the left) and reddish (on the right) scoriae.

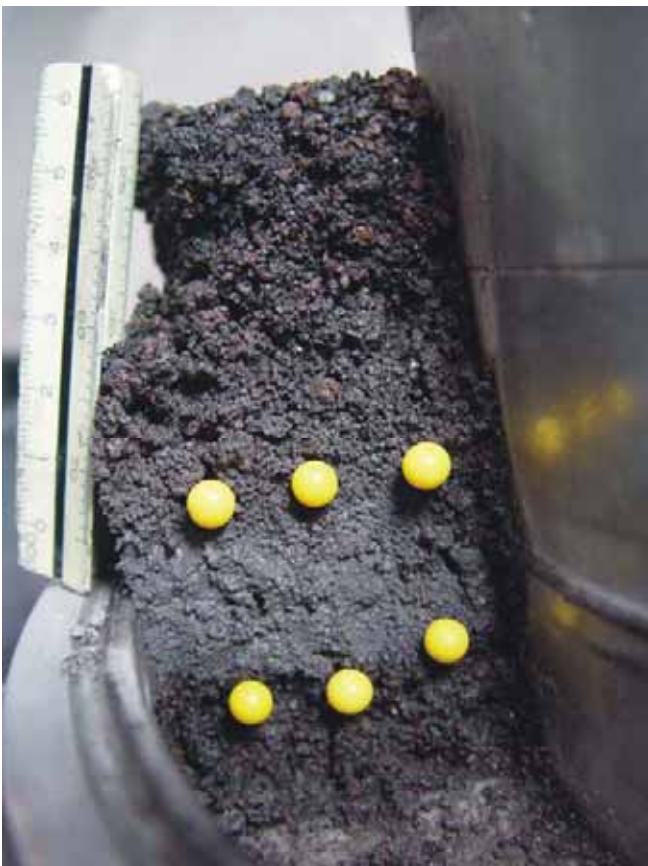
Fig. 11 View of the shear zone after the test

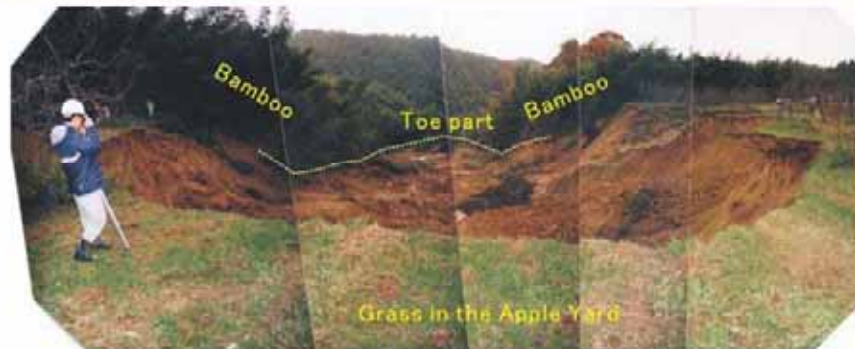
Figure 2 shows the first flowslide which occurred on November 8, 2002. The width and length of the source area were about 60 m and 100 m, respectively. The height of the main scarp was about 10 m, and the moving distance of the main sliding mass was more than 100 m. Fresh weathered mudstone was outcropped because most of the displaced sliding mass moved out of the source area. In this event, an apple yard in the source head area was damaged, and a local road near the flowslide toe was cut. The bamboo grove on the slope was completely destroyed. To prevent further debris flow hazard, a debris retention dam was built in front of the toe part of the debris deposits after the occurrence of the flowslide.

Fig. 2 Photograph of the first flowslide occurred on November 8, 2002 in Yamashina area (photo courtesy of Agriculture and Forestry Central Administration office, Ishikawa prefecture)

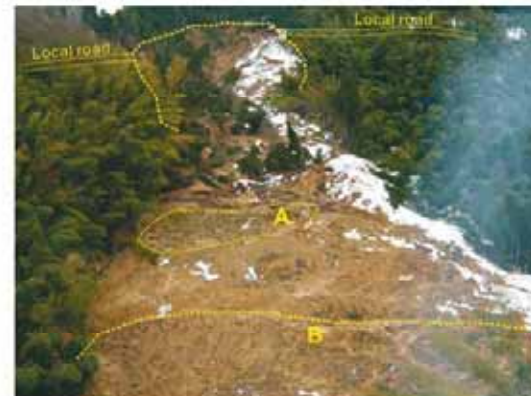
Fig. 8 Air photo of the second flowslide occurred on December 31, 2003 (taken with remote-controlled camera in balloon, photo courtesy of Agriculture and Forestry Central Administration Office, Ishikawa Prefecture). (A) The grass previously distributed in the apple yard behind the main scarp of the first flowslide. It moved for 200 m as a whole block. (B) Deposit of the first flowslide. It bulged up because of the pushing by the second flowslide.

this time was estimated to be about 50,000 m³. The blue sheets left on the main scarp were used to protect water infiltration through the crack into the slope. The weathered mudstone with yellow color was observed. Figure 9b shows the edge of the sliding mass of the second flowslide. At the toe part is the grass which previously existed

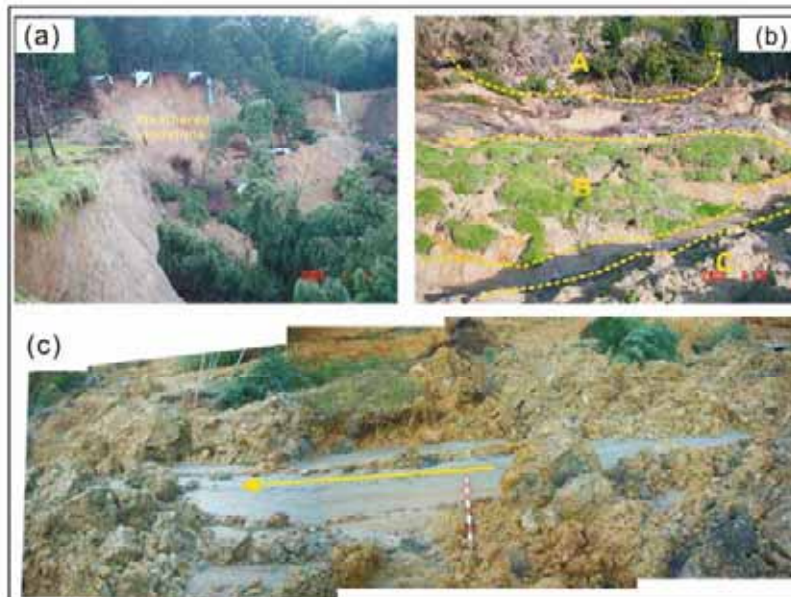
Fig. 10 A possible mechanism of the second flowslide. **a** In the period of rainfall and snowmelt, debris of the first flowslide was saturated, and the cracks behind the main scarp were filled with water. **b** Debris of the second flowslide moved rapidly on the saturated debris of the first flowslide with small shear resistance

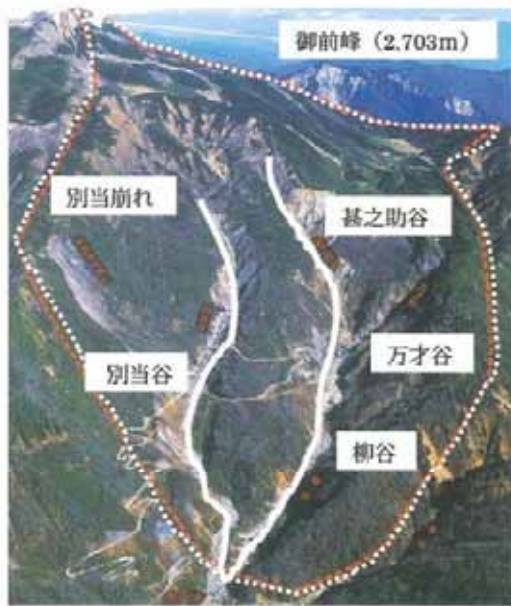
基之助谷地すべり周辺にも幾つかの崩壊ブロックが分布しており、それらを含めて、1962年に「地すべり防止区域」に指定された(図-3)。防止区域内では多くの斜面崩壊現象が発生しており、植生で覆われていない斜面は全て過去に斜面崩壊が発生した斜面、あるいは現在でも崩壊現象が起こっている斜面である。本報告の対象となる基之助谷地すべりは写真中央に位置しており、長

図-3 基之助谷地すべりの航空写真 (国土交通省の航空写真に加筆)

さ約2,000m、幅約500mで、海拔1,200m~2,100mの間に分布している。右岸側は別当谷であり、1934年に発生した別当崩れの滑落崖が残されている。左岸側には基之助谷(上流)と柳谷(下流)が存在している。土石流を防ぐために、1927年から現在までに、別当谷に約30基、基之助谷と柳谷に約50基の砂防ダムが建設されている。

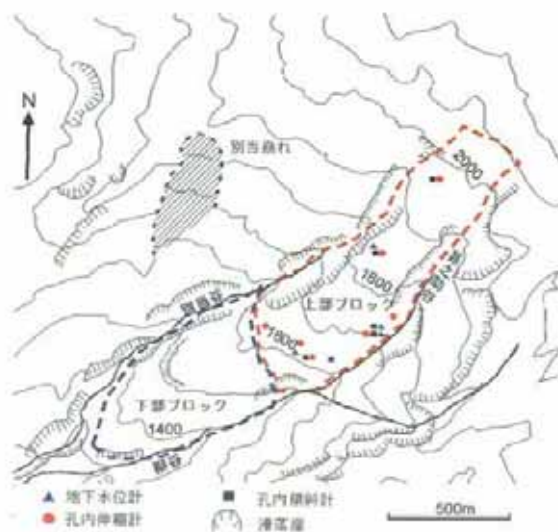
図-4 基之助谷地すべりとその周辺の地形図及び観測機器の位置

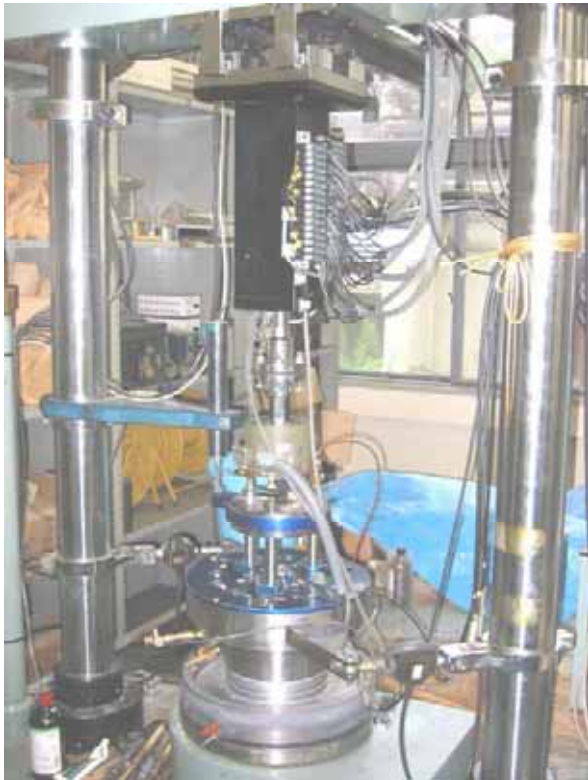
The results presented and discussed in this paper are from a new ring shear apparatus, hereafter referred to as DPRI-5, which is the fifth version of ring shear apparatuses available at Disaster Prevention Research Institute, Kyoto University, Japan. Designed, modified, and vastly improved by Sassa in 1996, DPRI-5 (Fig. 1) is reinforced with devices capable of sustaining undrain loading throughout the duration of a test. The apparatus is structured to eliminate some difficulties commonly encountered while studying the mechanism of landslide motion, and sufficiently equipped to allow speed-, and stress- controlled tests; and the measurement of very large shear displacement. Details of the structure and efficiency of the apparatus have been discussed comprehensively by Sassa et al. (2002), and Wang and Sassa (2001).

Fig.1 Picture of the ring shear apparatus

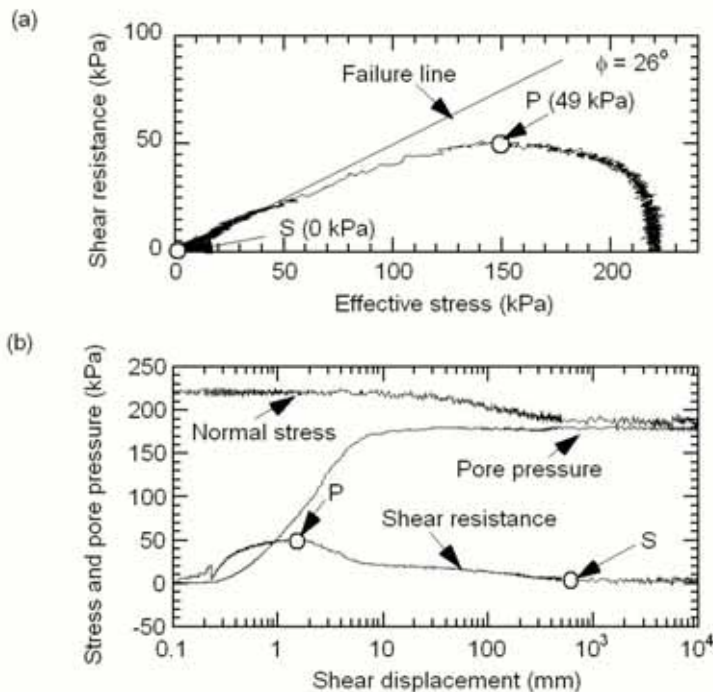
Fig. 3 Typical Complete liquefaction behavior of NAG specimen $D_r = 29.5\%$

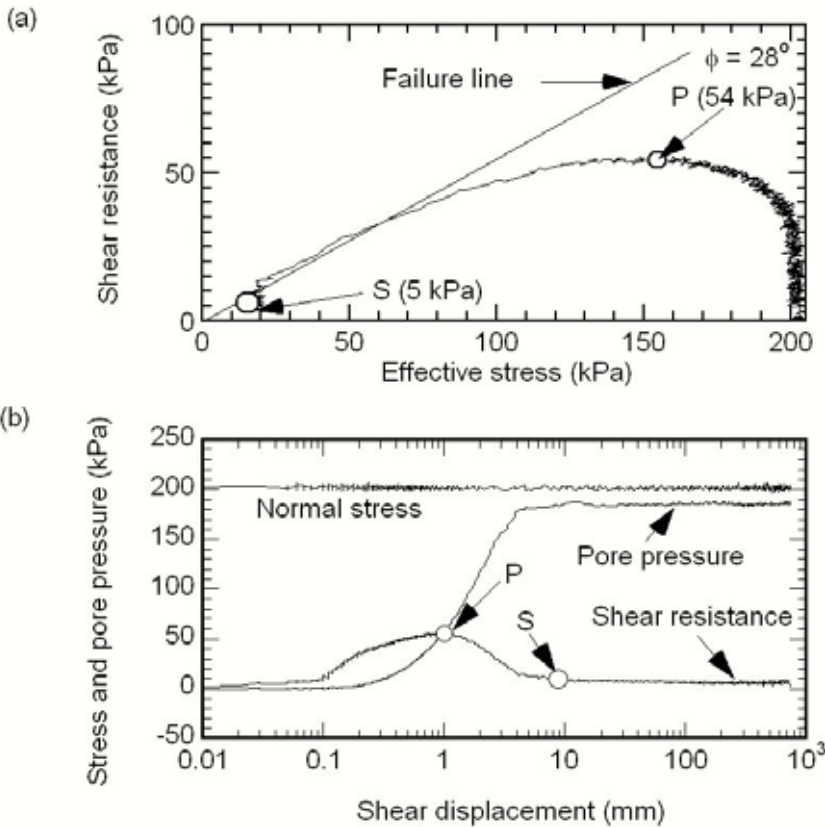
Fig. 4 Undrained response of ING specimen $Dr = 29.2\%$

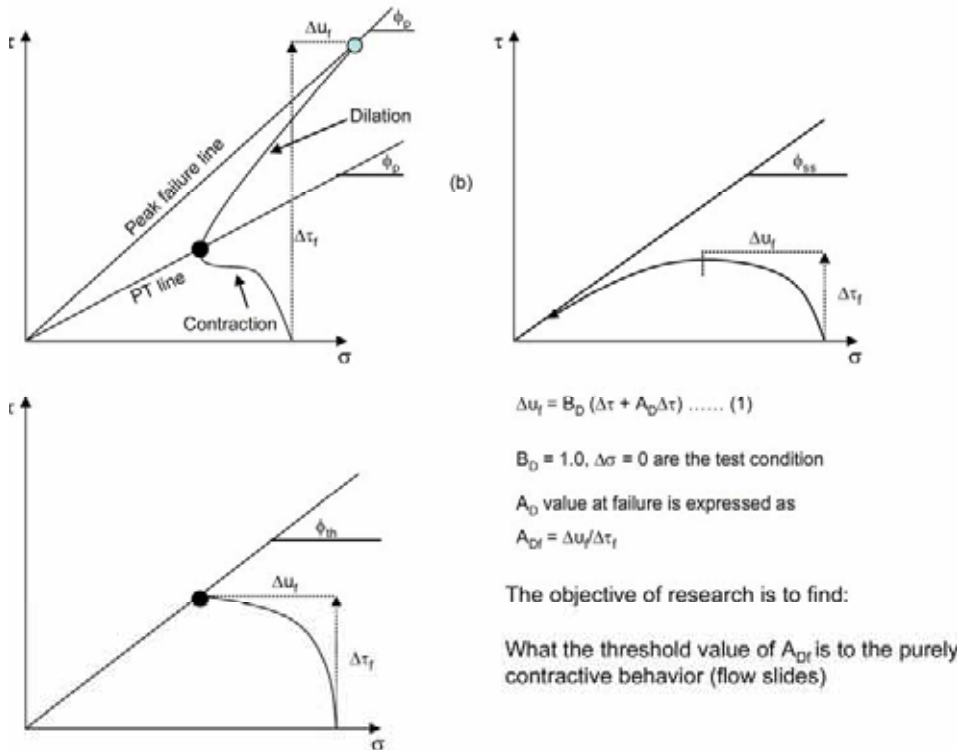
Fig. 30 The theory of threshold pore pressure

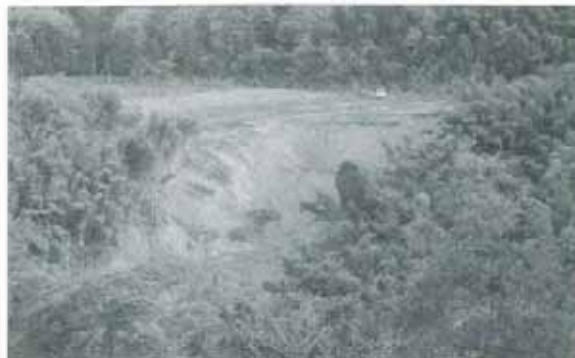
2002年11月8日に、石川県金沢市山科町で、源頭部の幅約60m、長さ100m、崩落崖の高さ約10m、移動距離約200mの流動化した山科地すべりが発生した (写真-1)。この地すべりの誘因は発生前13日間の連続降雨であると考えられる。この地すべりによって源頭部でりんご畑が崩壊し、末端付近で林道が抉られ、破壊された。地すべり発生後、地すべりによる土石流被害を防ぐための治山ダムが末端部に建設された。その後も崩落崖での

写真-1 2002年11月8日に発生した山科地すべり
Photo 1 The Yamashina flowslide occurred on 8 November, 2002

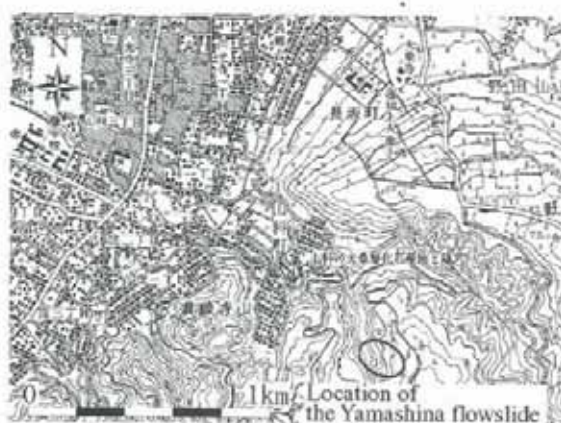
図-2 山科地すべり周辺の地形図(国土地理院25000分の1地形図「金沢」に加筆)

Fig. 2 Topographic map of the area around the Yamashina flowslide

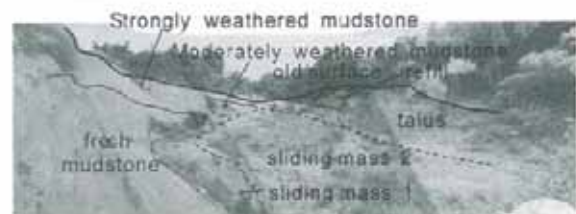
写真-2 山科地すべりの源頭部状況
Photo 2 Source area of the Yamashina flowslide

写真-2, 3は源頭部での露頭の特徴を示している。地すべり土塊1は写真左の新緑な泥岩に由来し、崩壊当時は青灰色であった。地すべり土塊2は写真奥の風化した泥岩に由来し、褐色で地すべり土塊1と明瞭に区別できた。堆積状況から地すべり土塊1の上位に地すべり土塊2が位置し、さざなみ状の地形が奥から手前に流れた

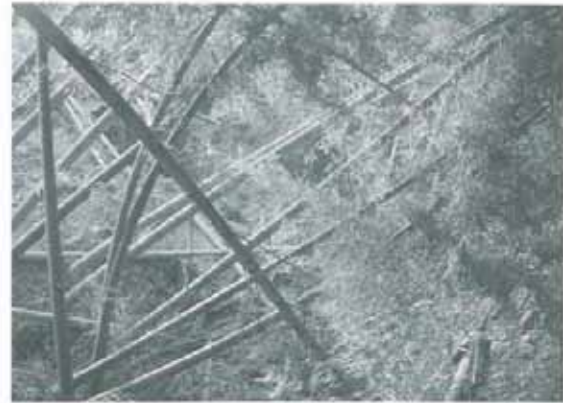
写真-4 堆積域の竹の状況

Photo 4 The bamboo in the deposition area

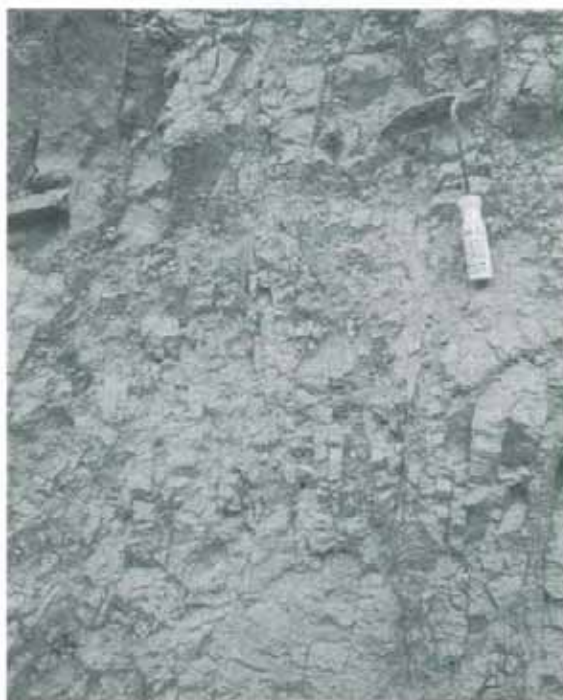
写真-5 滑落崖での風化泥岩の亀裂状況
Photo 5 The crack situation of the moderately weathered mudstone at the main scarp

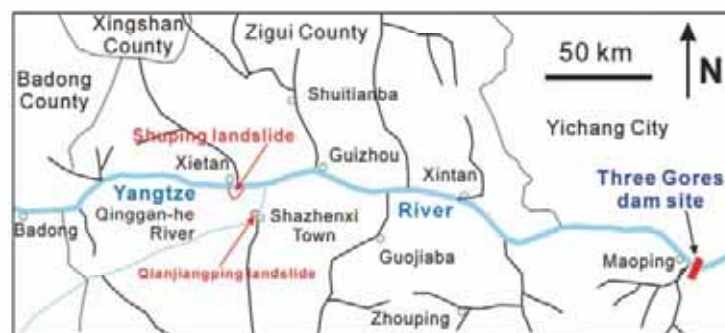
Aiming to study the influence of impoundment on landslide deformation, we selected Shuping landslide, which is located at the main stream of the Yangtze River (Fig. 40.1) in Shazhenxi Town, just about 3.5 km from the Qianjiangping landslide, as our research and monitoring field. Figure 40.2 is an oblique photograph of the Shuping landslide, and Fig. 40.3 is the plane of the landslide. The landslide ranged its elevation from 65 m to 500 m. Its width was about 650 m, the estimated thickness of the sliding mass was 40 m to 70 m according to the bore hole data, and the total volume was estimated as $2.0 \times 10^7 \text{ m}^3$. The toe part of the landslide was under the water level of the Yangtze River. The slope is gentle at the upper part and steep at the lower part with a slope angle of 22 degrees and 35 degrees respectively.

The Shuping landslide is an old landslide which composed of two blocks. This can be confirmed in the photograph (Fig. 40.2). After the first impoundment of the Three Gorges Reservoir ended on 15 June 2003, obvious deformation phenomenon appeared at the slope, and it became intense from 8 February 2004. Also, the two blocks shows different deformation rate at slope surface. The serious de-

Fig. 40.2. Shuping landslide consisting of two blocks at the main stream of the Three Gorges Water Reservoir

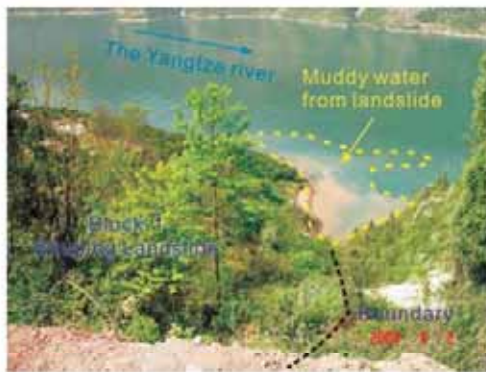
Figure 40.5 shows muddy water coming from block 1. It appears at the river even at continual sunny days showing no relationship with surface water erosion, but the underground water erosion from the inner part of the landslide.

Fig. 40.5. Muddy water seeped out of the toe part of the Shuping landslide

On 5 January and 8 February 2004: The water at the toe part of the landslide became very muddy. From March, the muddy water appeared almost everyday. Figure 40.5 shows the muddy water situation in April 2004. This phenomenon is a very dangerous sign for slope deformation, because it may mean that the newly sheared soil at the sliding surface was eroded by underground water gradually.

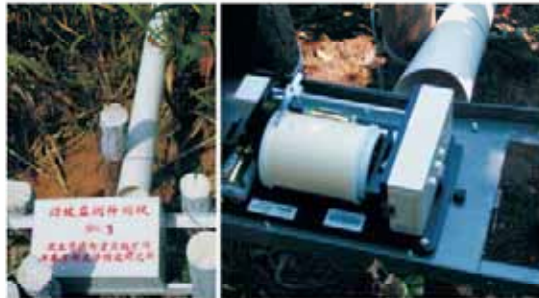
Fig. 40.8. Extensometer installed in Shuping landslide. The deformation is recorded on the rolled paper and also saved in a memory (visible in the right side)

Figure 40.8 shows the extensometer installed in Shuping landslide. The positions of all of the thirteen extensometers were shown in Fig. 40.3 as "SP1-x". Among them, SP1-1 and SP1-2 were set across the main scarp; SP1-3 to SP1-6 were set below the Shahuang road which has a high traffic. SP1-7 and SP1-8 were set almost parallel with SP1-5 and SP1-6. SP1-9 was set at the low part. Then, SP1-10, SP1-11, and SP1-12 were set near the Yangtze River at the toe part of the landslide. SP1-13 was set at the right boundary of block 1 shown in Fig. 40.4, because the crack extension is obvious.

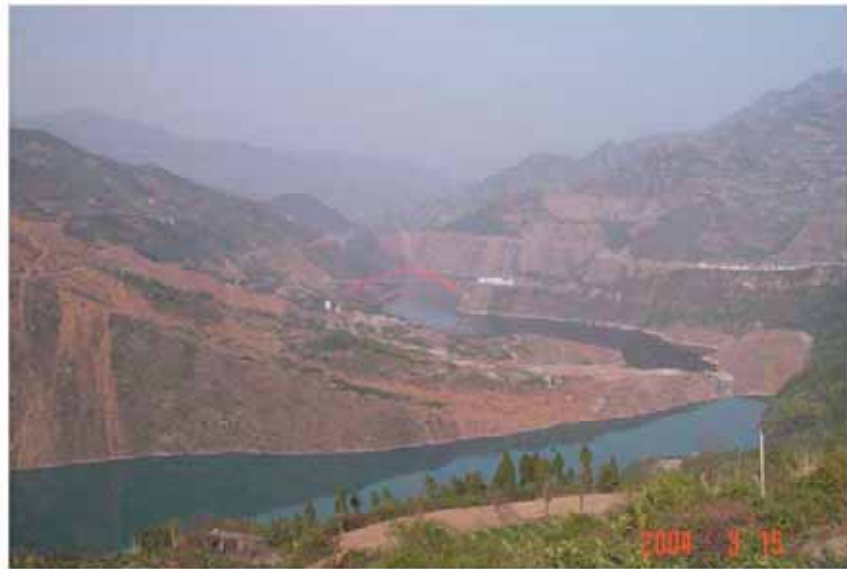
Fig. 3 Front-on view of the Qianjiangping landslide (taken by YM Zhang, July 15, 2003)

were located on the upper part of the landslide (Fig. 3), the associated high water table from irrigation should have been kept perched by the impervious weathered mudstone. The rice paddy was started ten years ago, and a pond for water supply was built near the paddy. So, for landslide stability analysis, the boundary conditions for the landslide are very clear. There was little volume of landslide in the uppermost part. The right lateral boundary was open, and so had no friction to resist sliding. As shown in Fig. 8, the sliding surface was a pre-existing structural shear-plane.

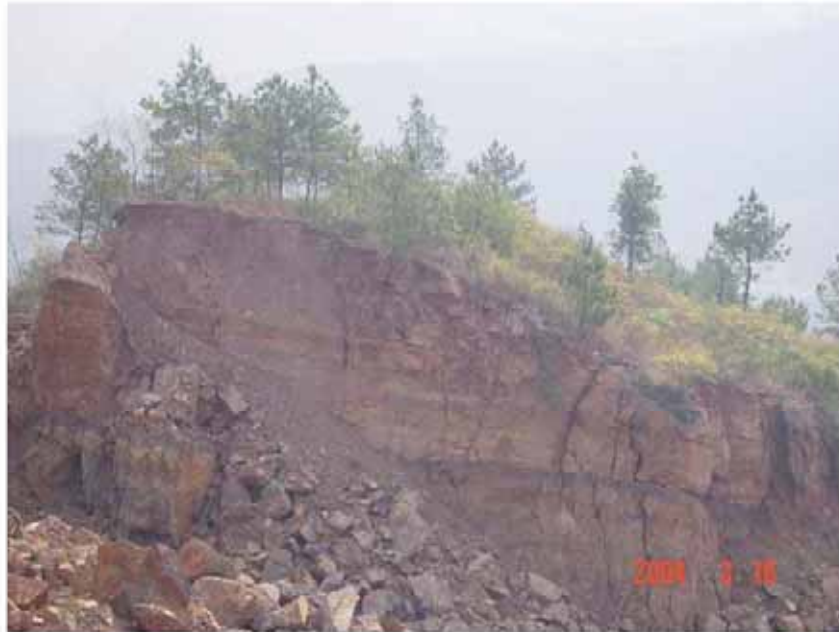
Fig. 5 The exposed planar sliding surface, which is also a sandstone-bedding plane (there is a damaged rice paddy in front of the person)

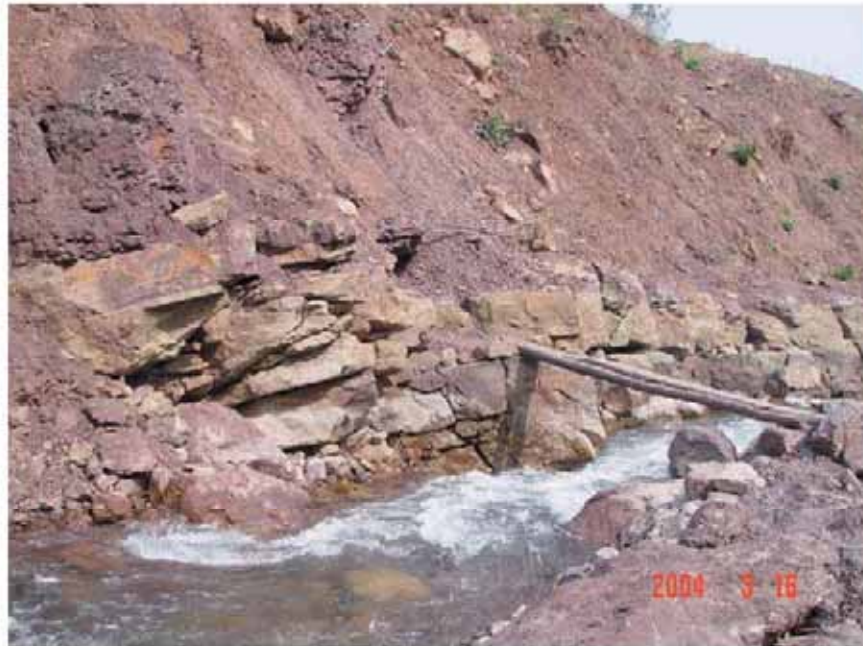
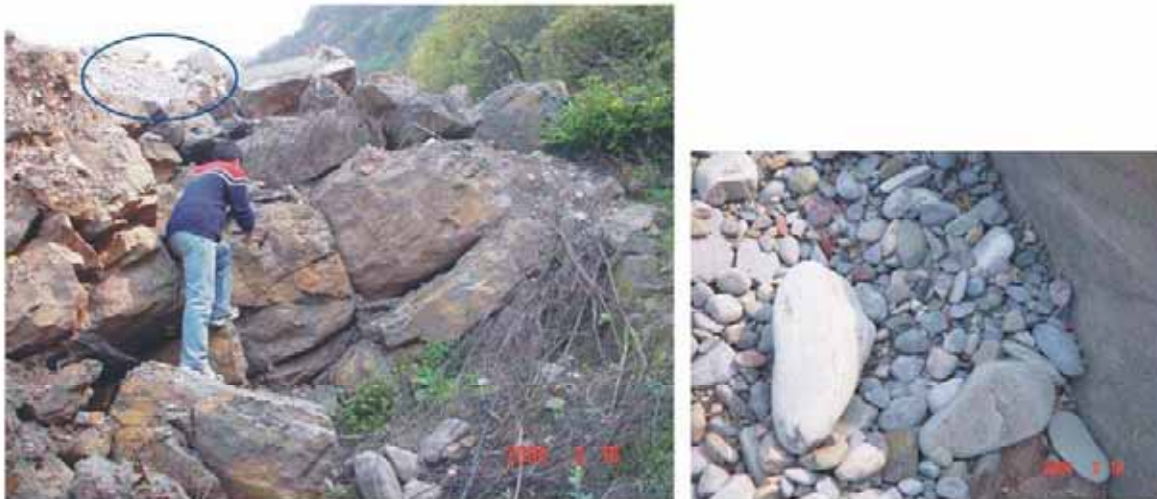
Fig. 6 View of the reversed dip direction of the sandstone beside Qinggan-he River (taken by FW Wang, March 16, 2004)

Fig. 7 Gravels displaced from the bed of Qinggan-he River and deposited in the toe of the landslide deposit (circled in photograph). Note that the sandstone dip direction is reversed and the dip angle has become steeper compared with Figs. 4 and 5)

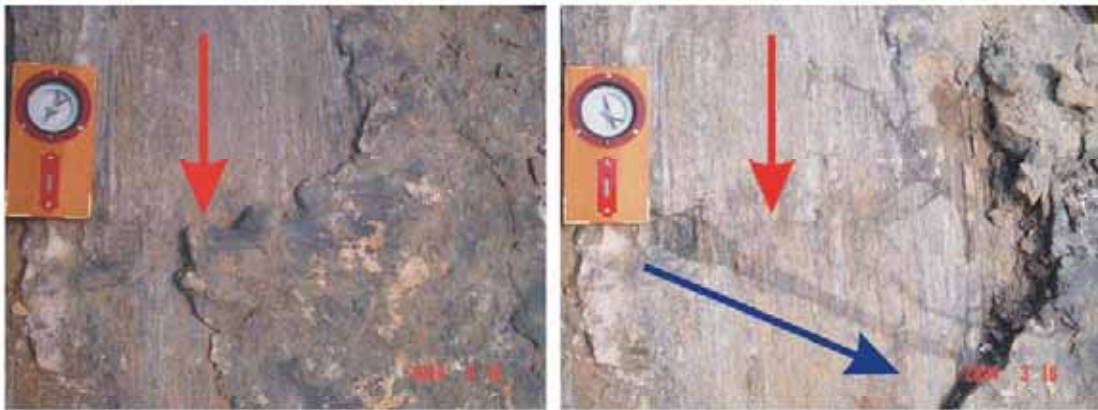
Fig. 8 A pair of photographs at the site showing the pre-existing scratches that underlie the sliding surface of the July 2003 event (blue arrow shows the sliding direction, red arrows show the strike direction of the pre-existing

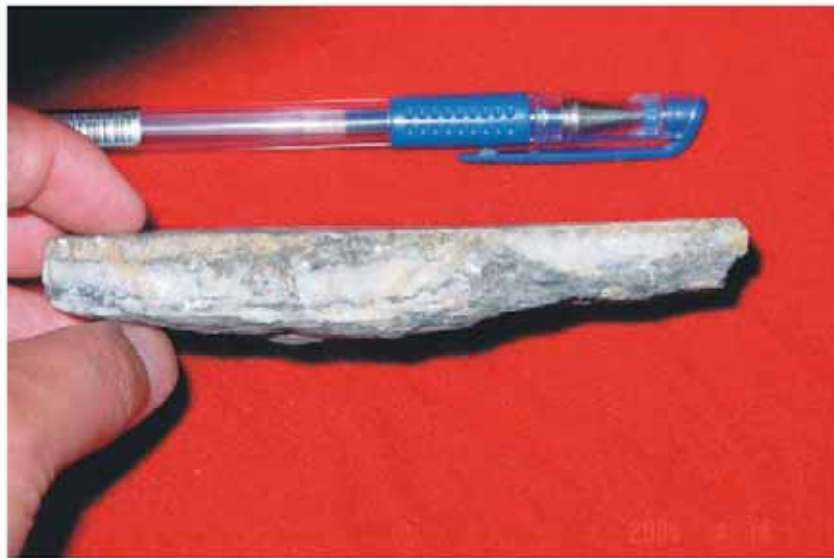
Fig. 11 Photograph of a crystalline calcite sample taken from the sliding surface at the upper part (the white color is crystalline calcite)

bonding would have been destroyed. The quick loss of adhesion of the crystalline calcite could be the main reason for the rapid landslide acceleration after the initial failure of the slope.

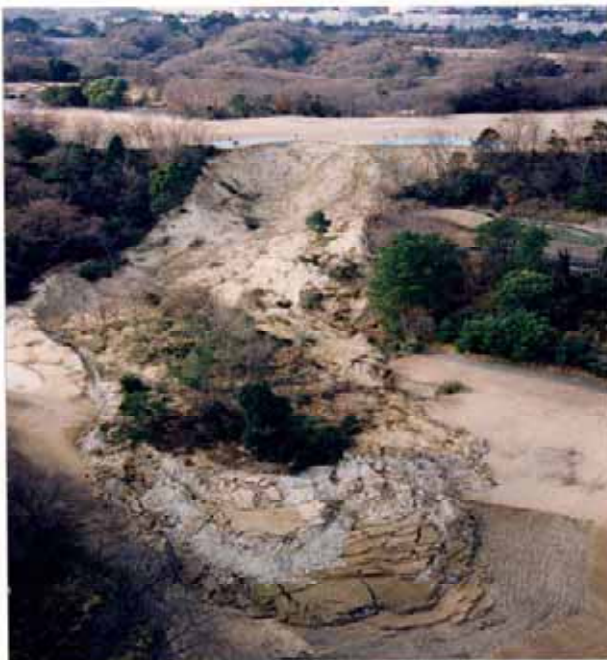
Artificially constituted silica sands and natural samples taken from the 1995 Takarazuka landslide (Fig. 3) that killed 34 people in Kobe, Japan were used to verify the concepts. Both the artificial and natural samples have similar physical properties, and indeed have almost the same friction angle.

Fig. 3 Picture of the Takarazuka landslide that followed the Great Hanshin earthquake of 1995.
