FIELD TRIP TO SHOBARA HILLS AND ENVIRONS

Organized by : Japan Landslide Society (Kansai Branch)

Date : 28th September, 2011

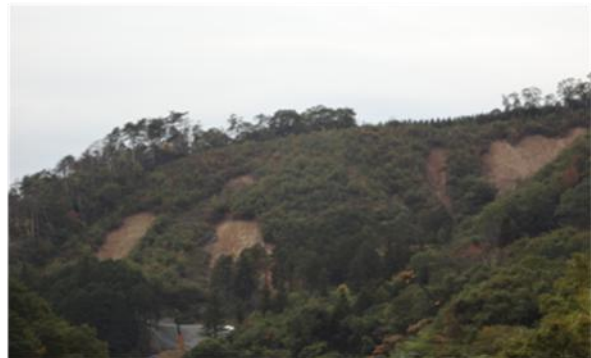
- Generally, a close observation from a distance of about 50m on Shobara Hills show a characteristic side-by-side feature of the Hills. The landslide surfaces (failure plane), were seen to be reddish to brownish coloured while the stable vegetation cover lies adjacent to the landslide surface. This characteristic feature is similar to an unripe (green) orange that is peeled in a like fashion where its skin is removed in spaces of 3cm. Prof. F. Wang termed the phenomenon '**Skin Failure.**'

fig 3: Characteristic differential "peeling" of some parts of Shobara Hills
