Analysis on the mechanism of landslides triggered by impoundment of water reservoir and development on the deformation prediction method

Fawu WANG (Kyoto University)

Abstract

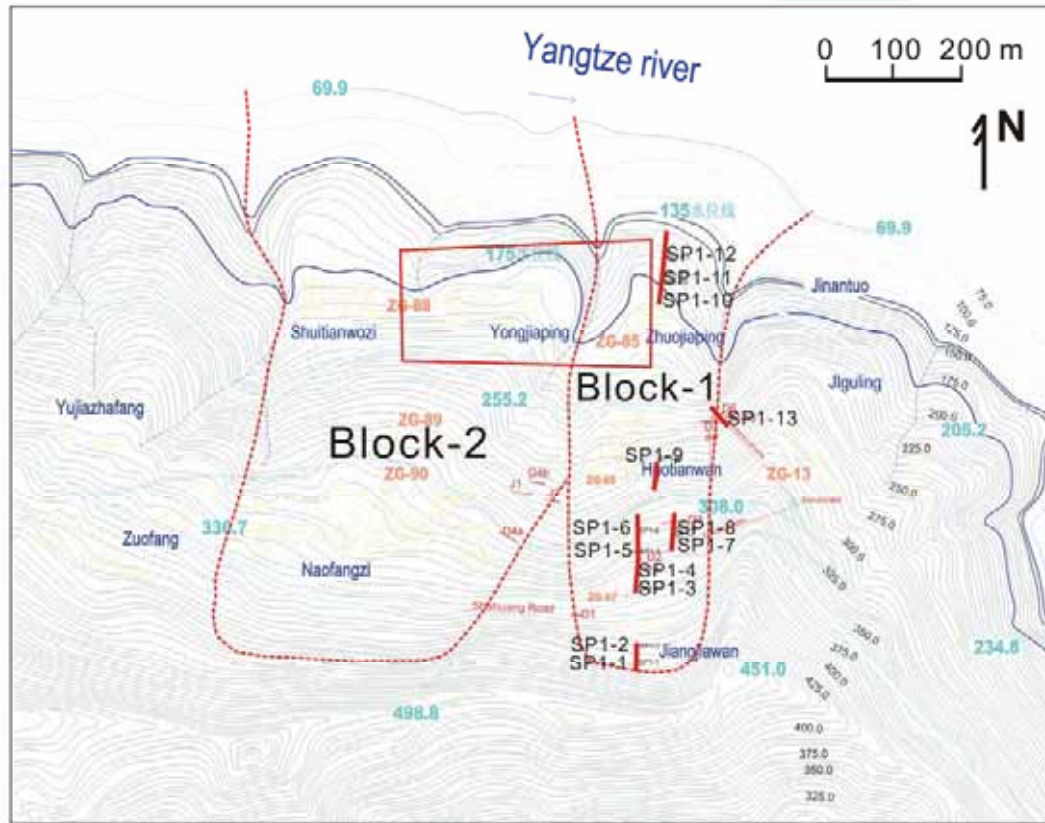
Fig. 12 Shuping landslide consisting of two blocks at the main stream of the Three Gorges Water Reservoir

Shuping landslide is located at the main stream of the Yangtze River (Fig. 1) in Shazhenxi Town, just about 3.5 km from the Qianjiangping landslide. The deformation became active after the first impoundment of the reservoir. Fig. 12 is an oblique photograph of the Shuping landslide, and Fig. 13 is the plane of the landslide. The landslide ranged its elevation from 65 m to 500 m. Its width was about 650 m, the estimated thickness of the sliding mass was 40 m to 70 m according to the bore hole data, and the total volume was estimated as $2.0 \times 10^7 \text{ m}^3$. The toe part of the landslide was under the water level of the Yangtze River. The slope is gentle at the upper part and steep at the lower part with a slope angle of 22 degrees and 35 degrees respectively.

The Shuping landslide is an old landslide which composed of two blocks. This can be confirmed in the photograph (Fig. 12). After the first impoundment of the Three Gorges reservoir ended on June 15, 2003, obvious deformation phenomenon appeared at the slope, and it became intense from February 8, 2004. Also, the two blocks shows different deformation rate at slope surface. The serious deformation situation made 580 inhabitants and 163 houses in danger directly, and all of the inhabitants were asked to live in the disaster prevention tents which were provided by the central government. Until May 2004, most inhabitants moved their houses out of the landslide area.

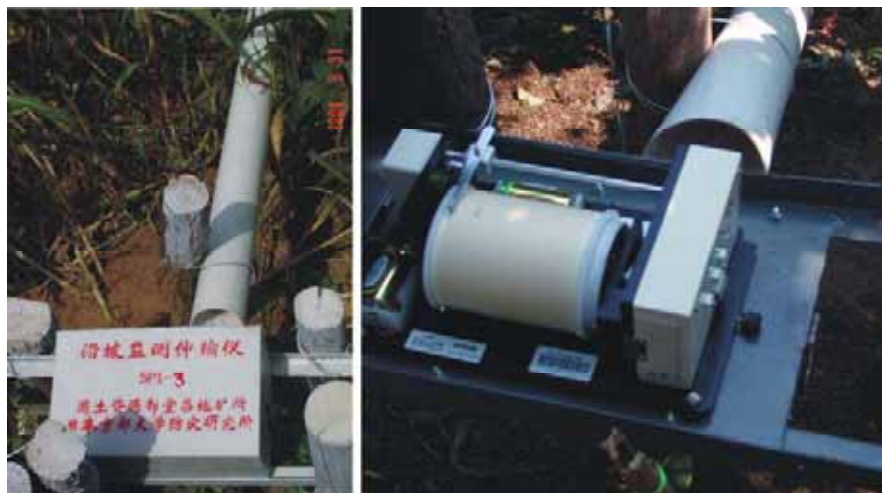
Fig. 18 Extensometer installed in Shuping landslide. The deformation is recorded on the rolled paper and also saved in a memory (visible in the right side)

Fig. 18 shows the extensometer installed in Shuping landslide. The positions of all of the thirteen extensometers were shown in Fig. 13 as “SP1-x”. Among them, SP1-1 and SP1-2 were set across the main scarp; SP1-3 to SP1-6 were set below the Shahuang road which has a high traffic. SP1-7 and SP1-8 were set almost parallel with SP1-5 and SP1-6. SP1-9 was set at the low part. Then, SP1-10, SP1-11, and SP1-12 were set near the Yangtze River at the toe part of the landslide. SP1-13 was set at the right boundary of Block-1 shown in Fig. 14, because the crack extension is obvious.

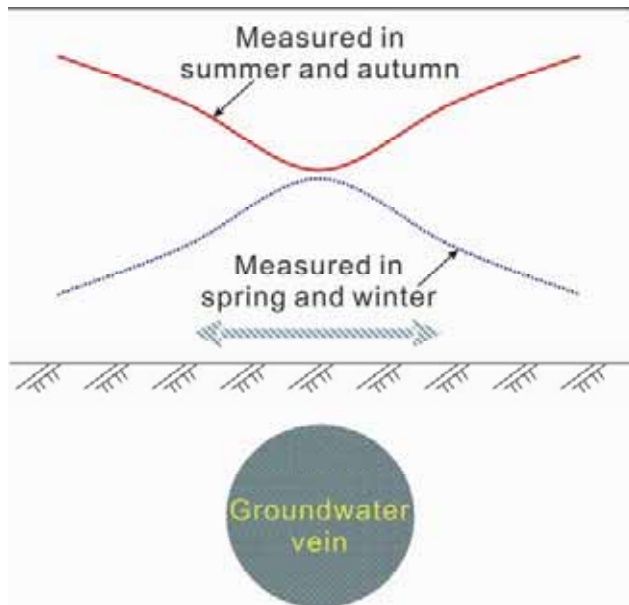
Fig. 20 Principle of the 1m-depth ground temperature measurement

vein. Comparing with the ground without water, the ground with water always has a temperature similar to that of the groundwater. Generally, groundwater temperature does not change so much around a year. While, the temperature in the ground without water is controlled by the atmosphere temperature, which will be higher than groundwater in summer and autumn, and lower in spring and winter. Through measuring the temperature distribution in an area, the distribution situation of groundwater vein can be estimated.
